## BS5837 Tree Survey, Arboricultural Impact Assessment and Method Statement.

Maelor Forest Nursery Fields Farm, Bronington, Wrexham, SY13 3HZ

12/10/20

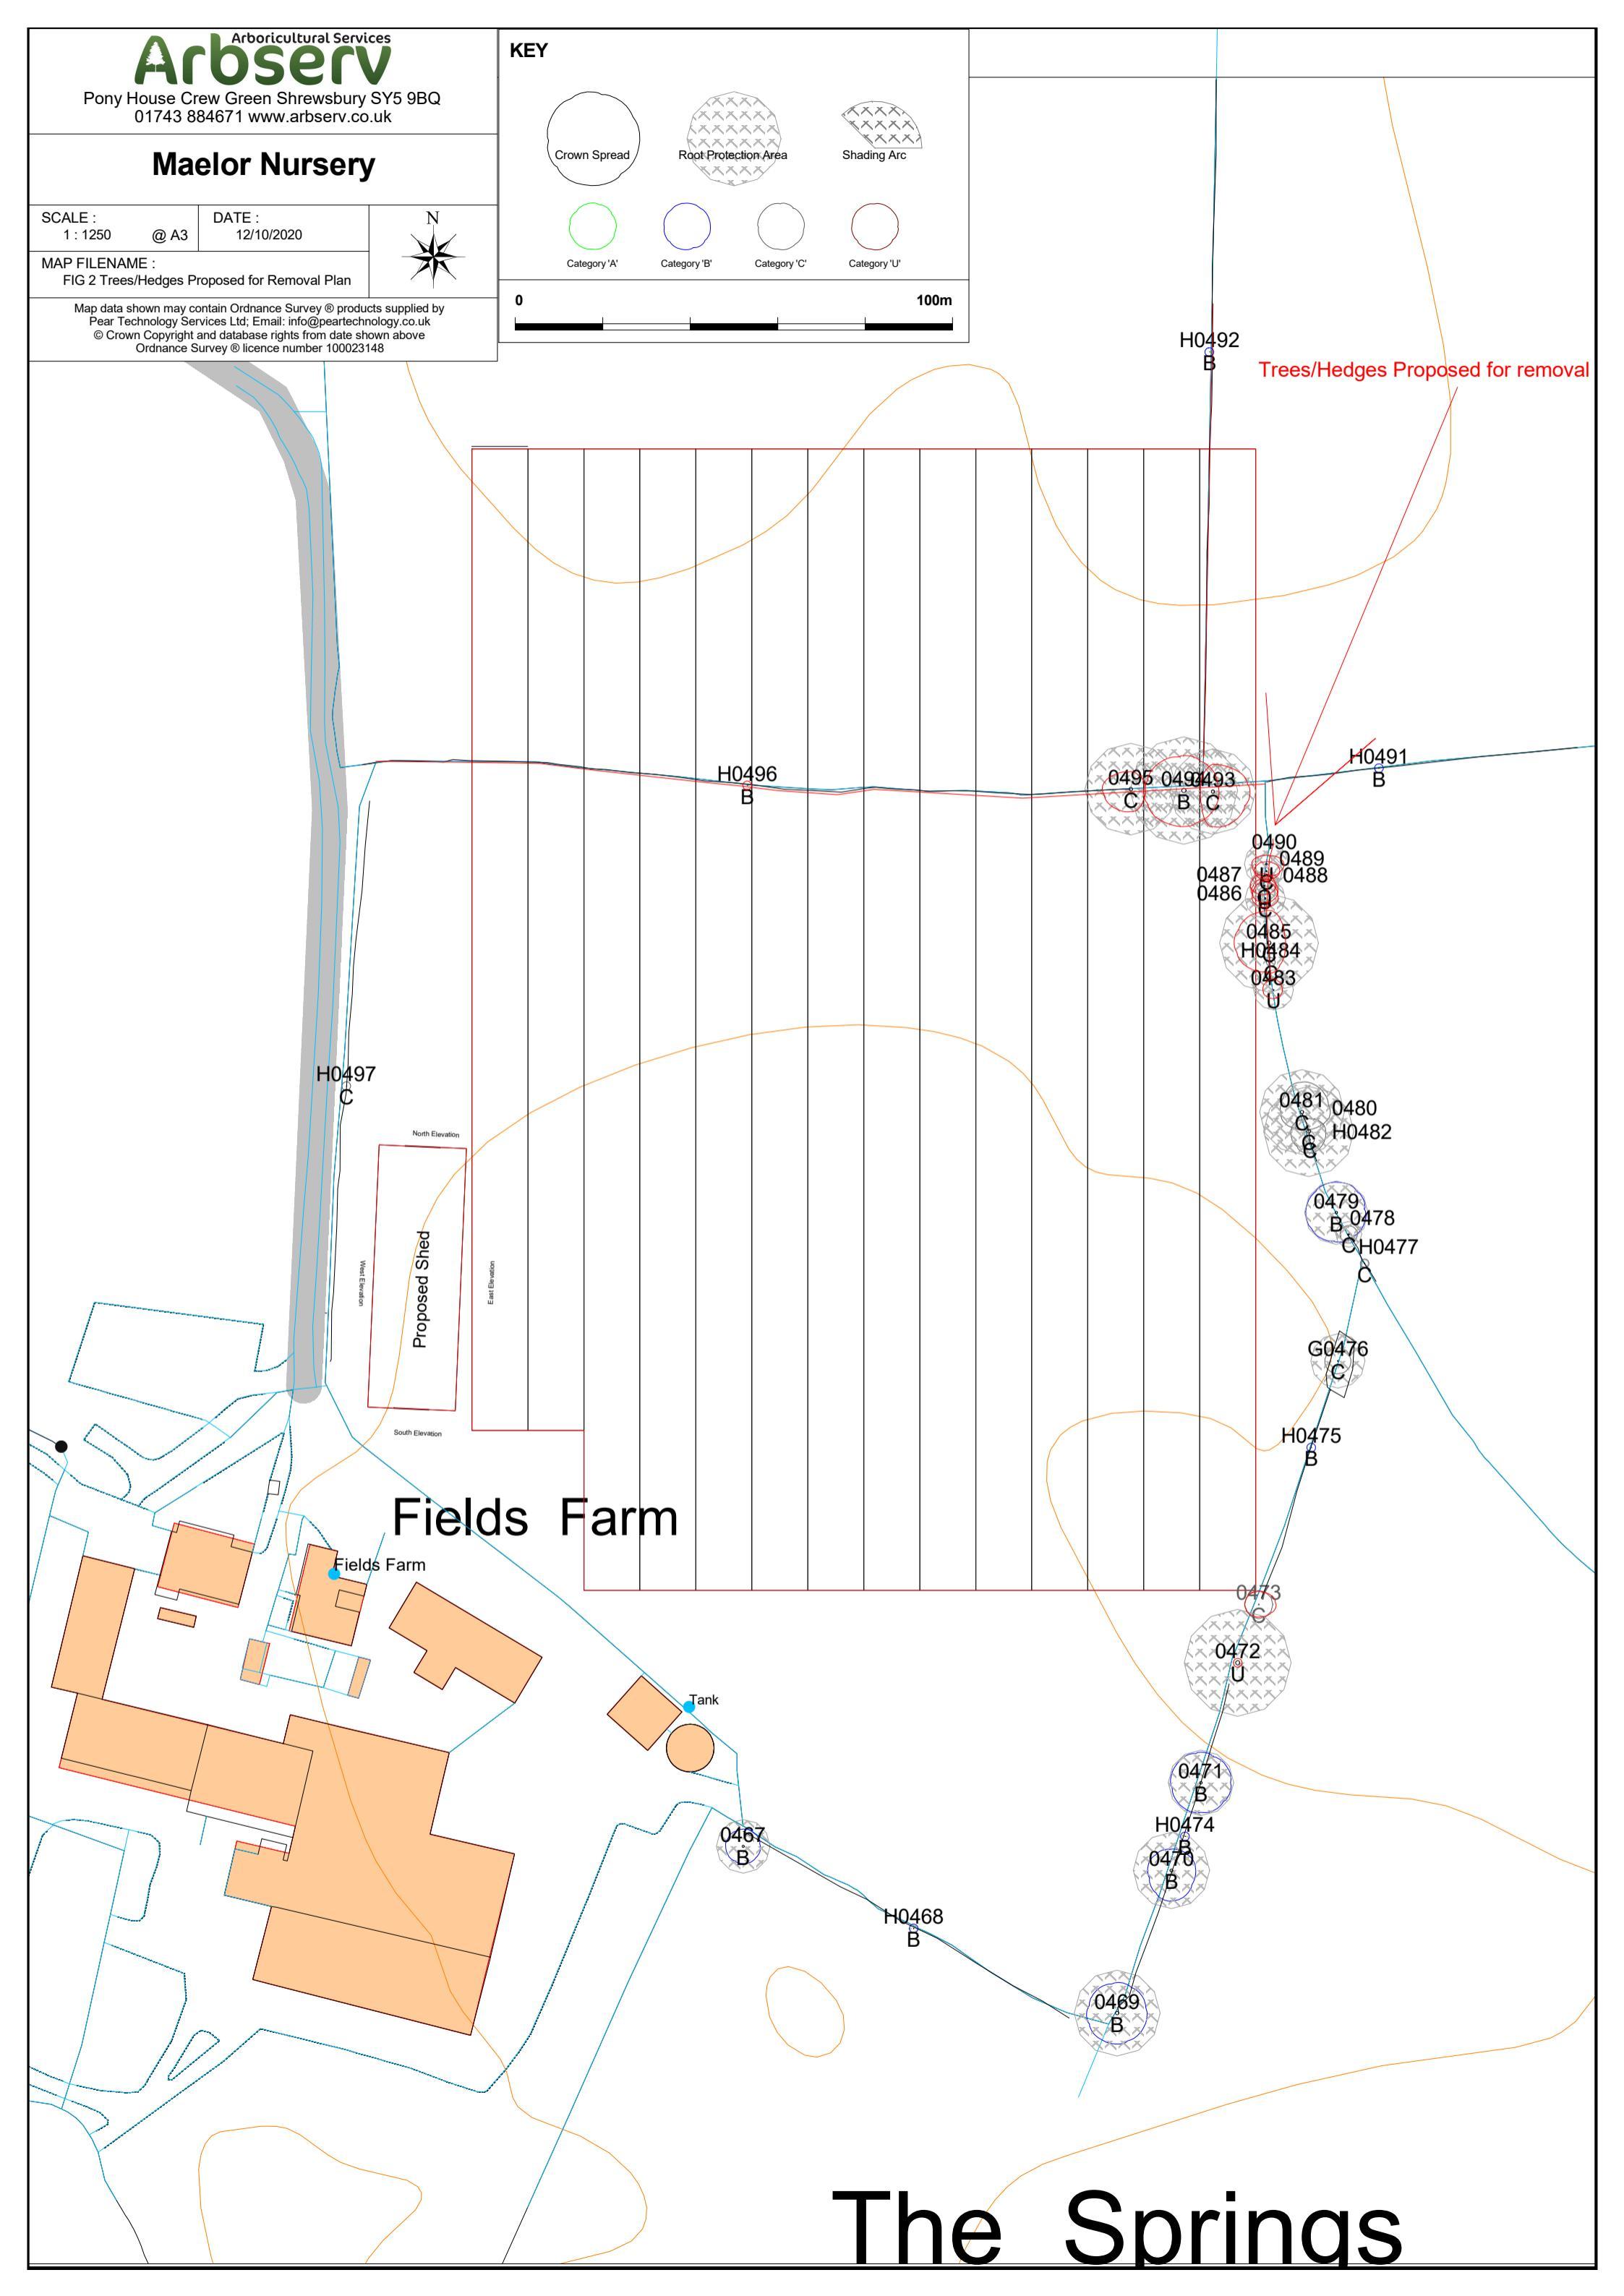
Appendix 2 figure 2 Trees Proposed for removal.

- 8.2 Four category U trees unsuitable for retention are proposed for removal. Category U those in such a condition that they cannot realistically be retained as living trees in the context of the current land use for no longer than 10 years.

- 8.3 Three sections of hedge are proposed for removal: H0496 runs through the middle of the proposed polytunnel development and much of this hedge 200 metres is proposed for removal. Whilst it is in overall good condition, it is made up of both established and relatively young woody plants. H0492 has 100 metres section proposed for removal to accommodate the new structure but whilst in good overall condition it is limited in species diversity, mainly being made up of hawthorn and maintained at a low height. H0484 is a smaller 35 metre section of hedge also proposed for removal which is in poorer condition along with most trees in this section of hedge. The stems which make up these hedges are principally below 75mm DBH. However, due to the length of hedge proposed for removal (over 20 metres) they have been included in this report. As highlighted by the preliminary ecology assessment the construction of the unit would result in some hedgerow loss. This will require mitigation and will involve the replanting of an equivalent meterage of species rich hedge as part of the site landscape design.

- 8.4 Seven trees 473, 485, 486, 488, 489, 493, 495 all category C are proposed for removal. These trees are of overall low quality. Tree 494, one over mature category B oak tree is also proposed for removal. The Arboricultural Impact for the proposed removal, compared to number of trees retained and the overall tree population at the Maelor Forest Nurseries Fields Farm, makes the Arboricultural impact for the whole site relatively low. Especially given that the proposed structure is key to nursery production of tree stock nationwide. Nevertheless, to mitigate the loss, especially T0494 Oak, succession tree planting is required which can utilise some of the hedgerow gaps across the farm. Many of the hedge line field boundaries are typical mature trees with maintained hedges between. Therefore, currently limited allowance is given for succession of the next generation of mature hedgerow trees, principally oak in this case. And so, there is an opportunity to offset the loss by succession planting which will be beneficial in the long-term. Please note trees have only been looked at from an arboricultural perspective, not an ecology perspective. This report must be read in conjunction with the preliminary ecology report and any sequential ecology reports before any work is carried out to trees (subject to planning).

- 9.2 Fell and remove all category U trees and trees proposed for removal in red on figure 2.
- 9.3 <u>Method out-side RPA</u> for all trees retained. The RPA shall be measured and clearly marked on site with the use of ground pins or marker spray. All relevant personnel should be briefed to ensure they are fully aware of the location and extent of the RPA'S Construction Exclusion Zone (CEZ). Install the section of Heras fence or similar barrier positioned as indicated on the tree protection plan to form a construction exclusion zone (CEZ).

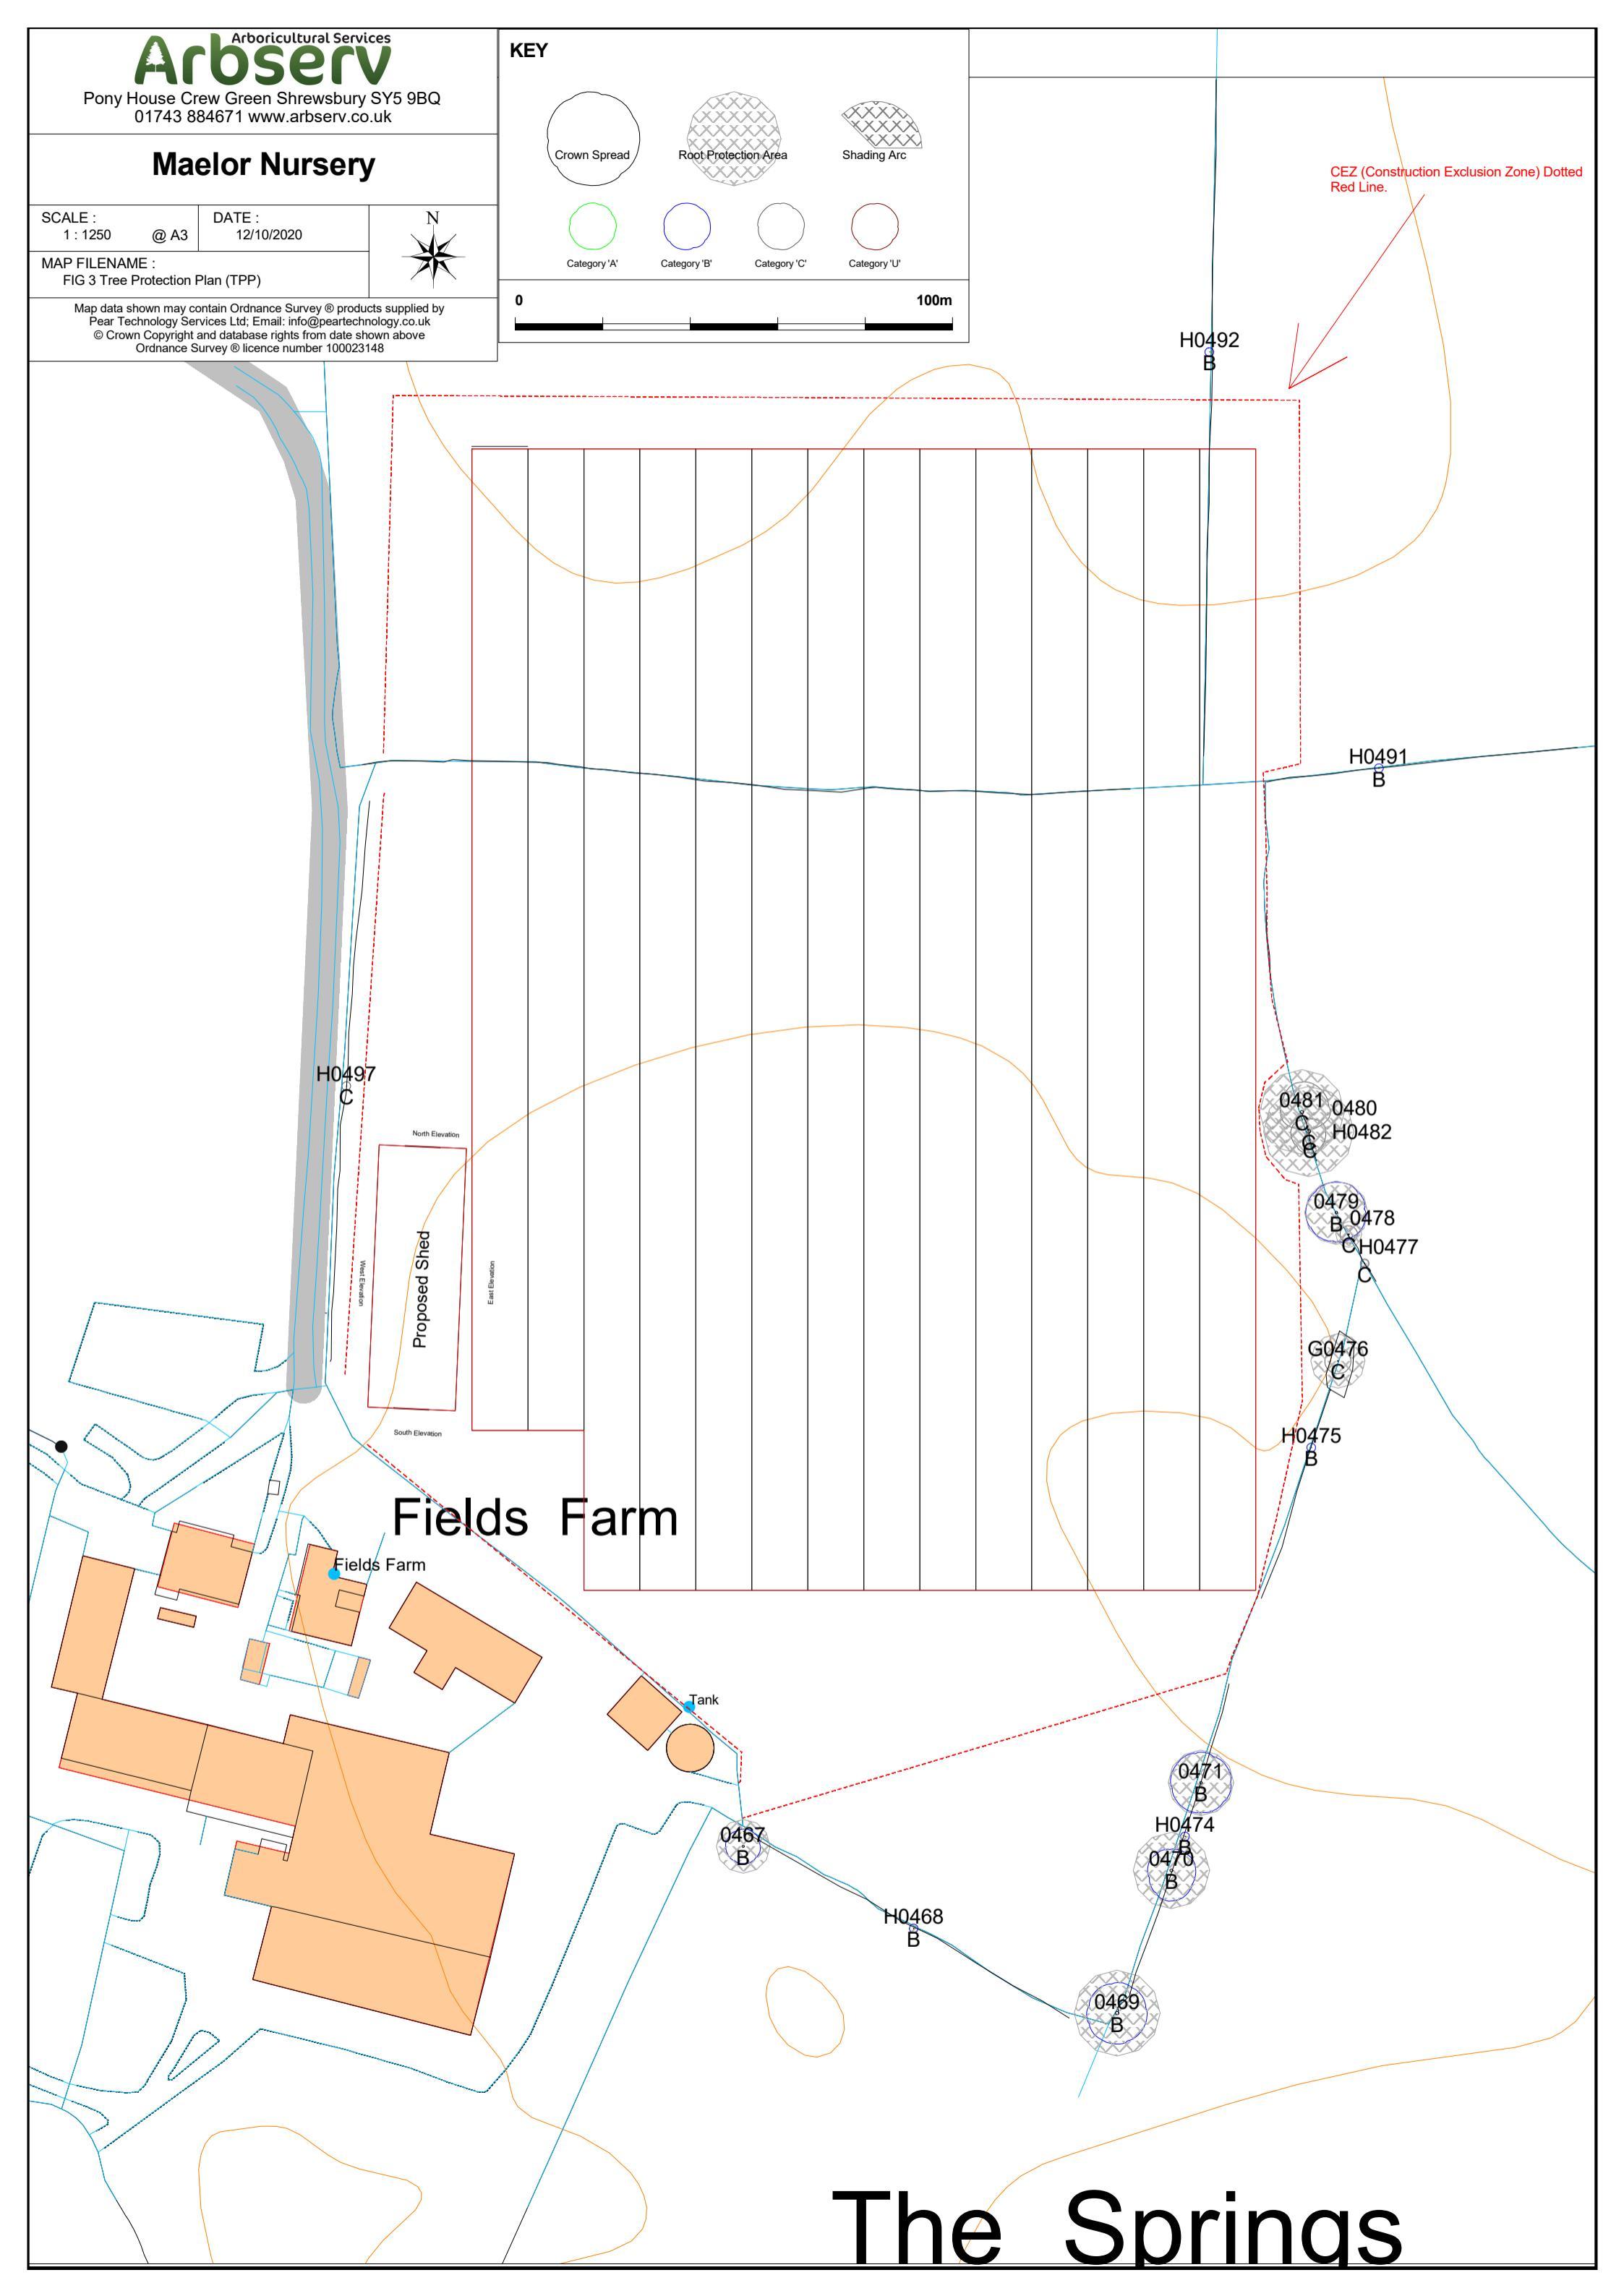
### Appendix 3 Tree Protection Plan.

- 7.3 The below ground constraints are marked as Root Protection Areas (RPA'S) on the tree protection plan figure 3. The concise arboricultural impact assessments and method statements are displayed in the survey comment of the tree survey table for each tree. This is to provide uncomplicated use by operatives along with the tree protection plan on site. The arboricultural impact assessment and method statement in this report provide more detailed information.

- 8.5 The proposed building and polytunnel structure fall out-side the RPA'S of all other trees and hedges in the site parameter. (see figure 3 Tree Protection Plan) The Arboricultural impact on these trees can be mitigated by following the <u>Arboricultural Method statement out-side RPA</u>.
- 8.6 The effects of shading represent a very limited impact to the proposed polytunnel structure because trees located to the south are located some distance from the proposed structure.

- 9.5 Weatherproof notices shall be attached to the protective fencing displaying the words Construction Exclusion Zone.
- 9.6 Ground levels should not be raised or lowered within the RPA and CEZ
