105419-S01

# Phase 1 Environmental Site Assessment

Proposed Poultry Installation on Land at Upper  
Maenllwyd Farm, Kerry, Newtown, Powys, SY16 4NB

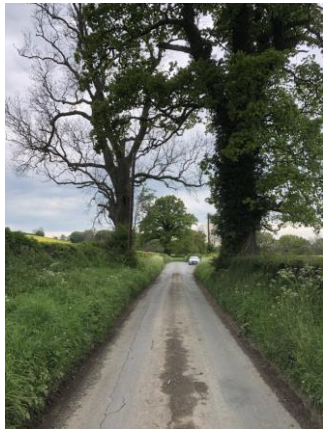
1

1. Facing west offsite along the southern boundary of the site.
2. Looking north east from the south east corner of the site.
3. Entrance of the adjacent historic landfill to the east of the site.
4. Gated entrance of the adjacent historic landfill.
5. Facing west onsite along the southern boundary of the site.
6. Facing east along the southern boundary of the site.

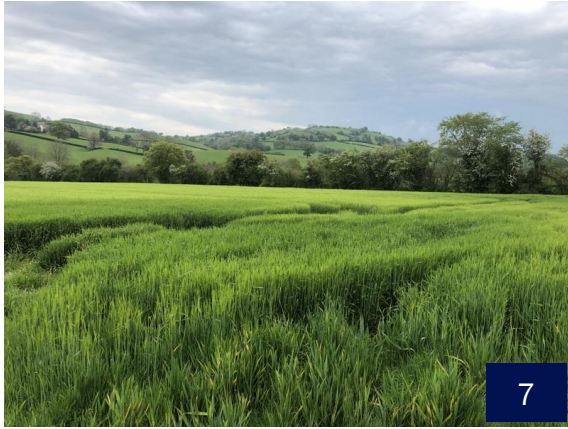
7

7. View of the north east of the site.
8. View of the northern portion of the site.
9. View towards the north west of the site.
10. Position at the centre of the site facing towards the northern boundary.
11. Facing north along the eastern boundary of the site.
12. Looking towards the north west of the site from the south east.

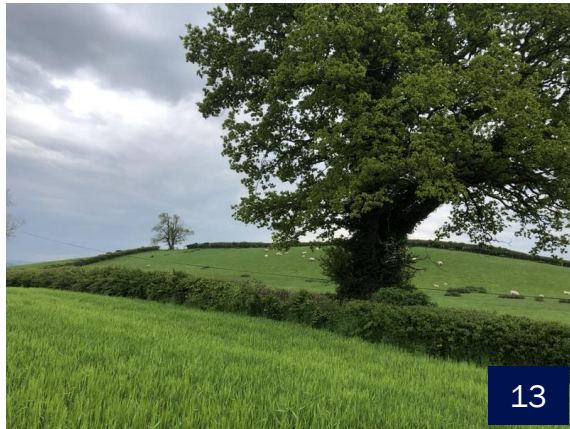
13

- 13. Facing north towards the southern boundary.
- 14. Positioned on the western boundary looking north towards the north western corner of the site.
- 15. View of adjacent land to the north.
- 16. View of adjacent land to the north.
- 17. The River Mule 90m to the north of the site.
- 18. Additional view of The River Mule to the north.

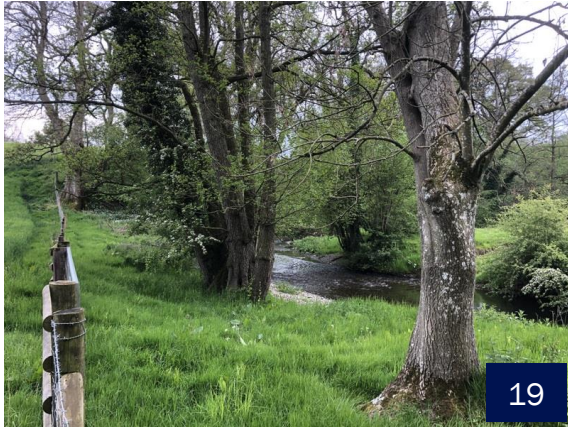
19. Additional view of the River Mule to the north.

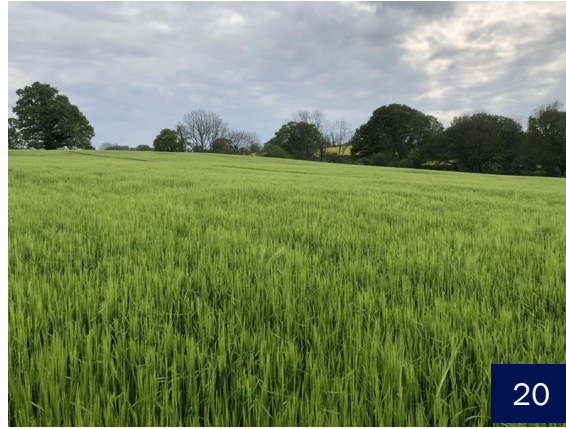
20. View onsite facing south west towards the south west corner of the site.
