New Storage Shed at Penrhos Farm, Penrhos, Llanymynech, Powys, SY22 6QH Desk-Based Assessment

For: Roger Parry & Partners

Trysor Project No. 2018/615

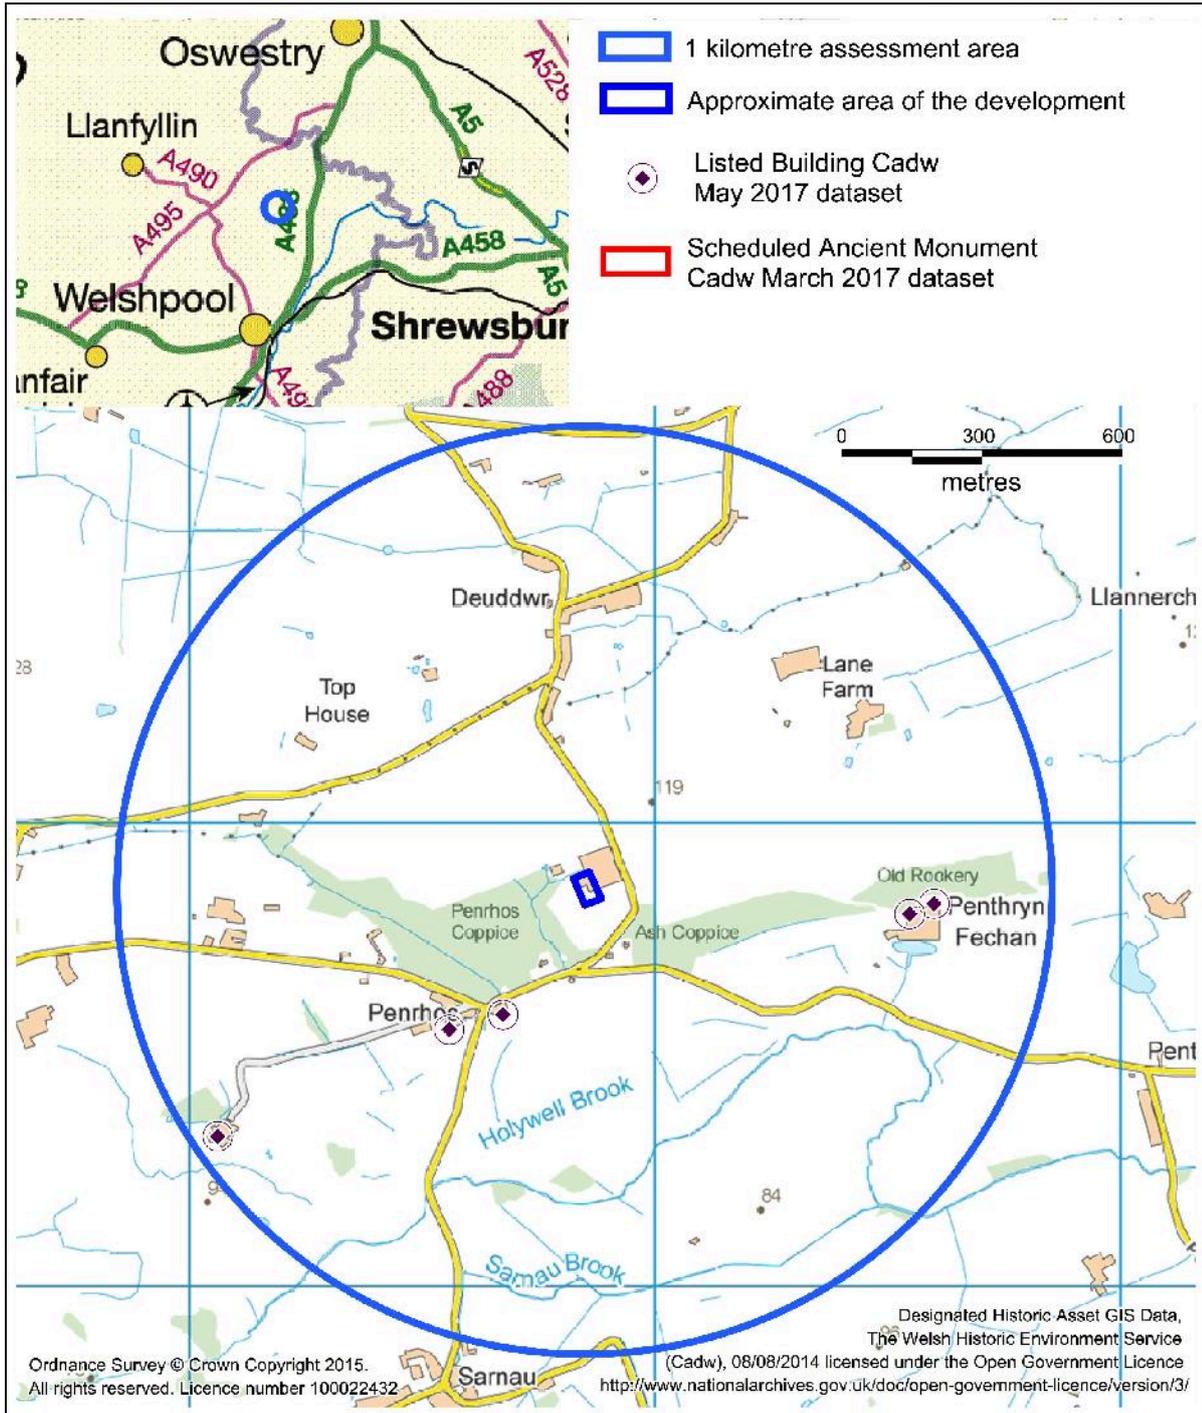
Figure 1: Location of the development, showing the 1km radius assessment area.

- 5.1 The desk-based assessment considered known historic assets within a 1 kilometre radius circle centred on SJ2384916854, the centre of the development (see Figure 1). This has helped develop an understanding of the archaeology and landscape of the surrounding area as well as assess any direct or indirect impacts, including impact on setting. Historic assets have been given an ID number for the purposes of this report, other reference numbers, such as regional HER PRNs are cross referenced in Appendix B.

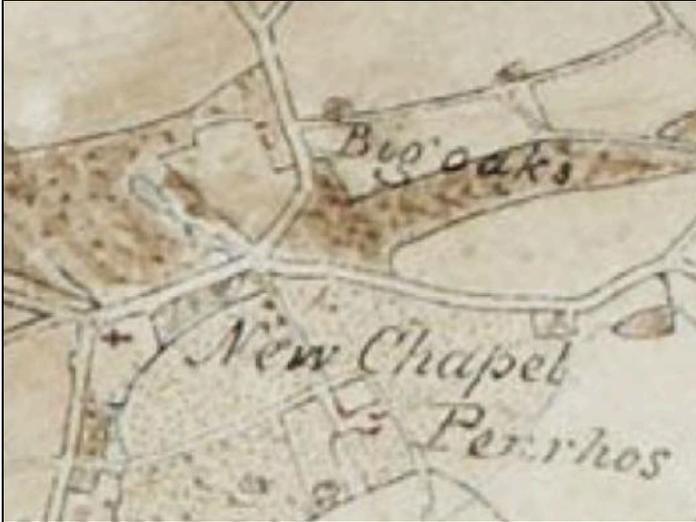
Figure 2: The 1813 Ordnance Survey Original Surveyors Drawing shows a building at the site of the present house at Penrhos Farm, apparently called Big Oaks at the time the map was prepared. There may be a second building to the north of the house.

- 8.3 The earliest map showing the property is the Ordnance Survey's Original Surveyors Drawings, Meifod sheet, surveyed in 1813. The Original Surveyors Drawings represent the first detailed map series of the whole country. They do not generally map field boundaries in detail although some basic details of the field system are shown on the 1813 map for the area around Penrhos Farm. A building appears to be shown at the site of the house on this map, which it names as "Big Oaks." There may be a second building to the north of the house site but the map is indistinct.

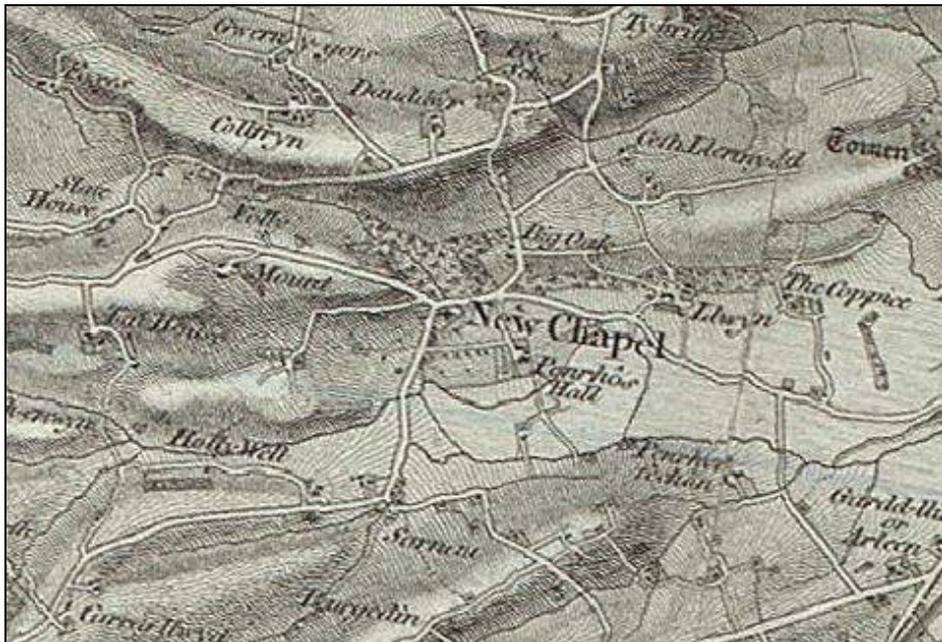
Figure 3: Penrhos Farm as shown on the 1836 Ordnance Survey map. Again the property is shown as Big Oak. Note Penrhos Hall to the south.

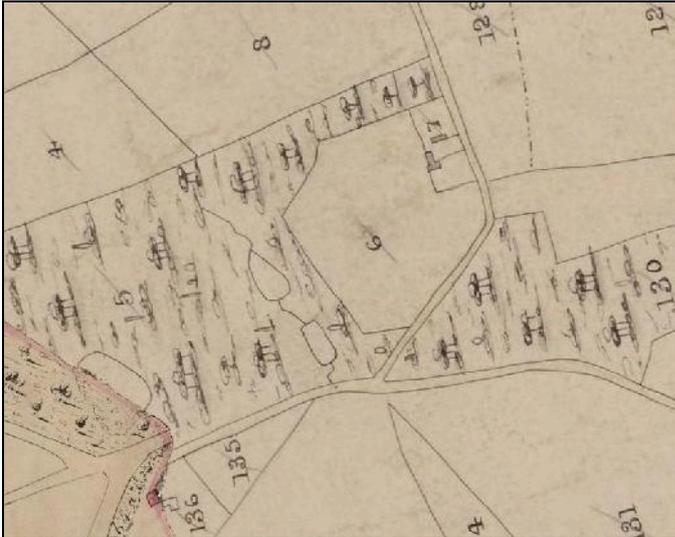
Figure 4; An excerpt from the Llandrinio parish tithe map of 1841. The development site falls within field parcel number 6, which was a field known as Big Oak field on the tithe schedule.

- 8.6 The first detailed map of the field system of the area is the Llandrinio parish tithe map of 1841. This map is the first to show a clear depiction of the layout of the farmyard buildings at Penrhos Farm. It shows the T-shaped house in its present position, with a single, rectilinear outbuilding to the northwest and a smaller outbuilding to the north. The present house may incorporate parts of the house shown on this map. The development site is shown on the tithe map and falls within field parcel number 6, which is named as "Big Oak Field" on the tithe schedule.

11.14 There are no field names of archaeological significance at the development site. The development has taken place in an field named *Big Oak Field* on the 1841 parish tithe map.

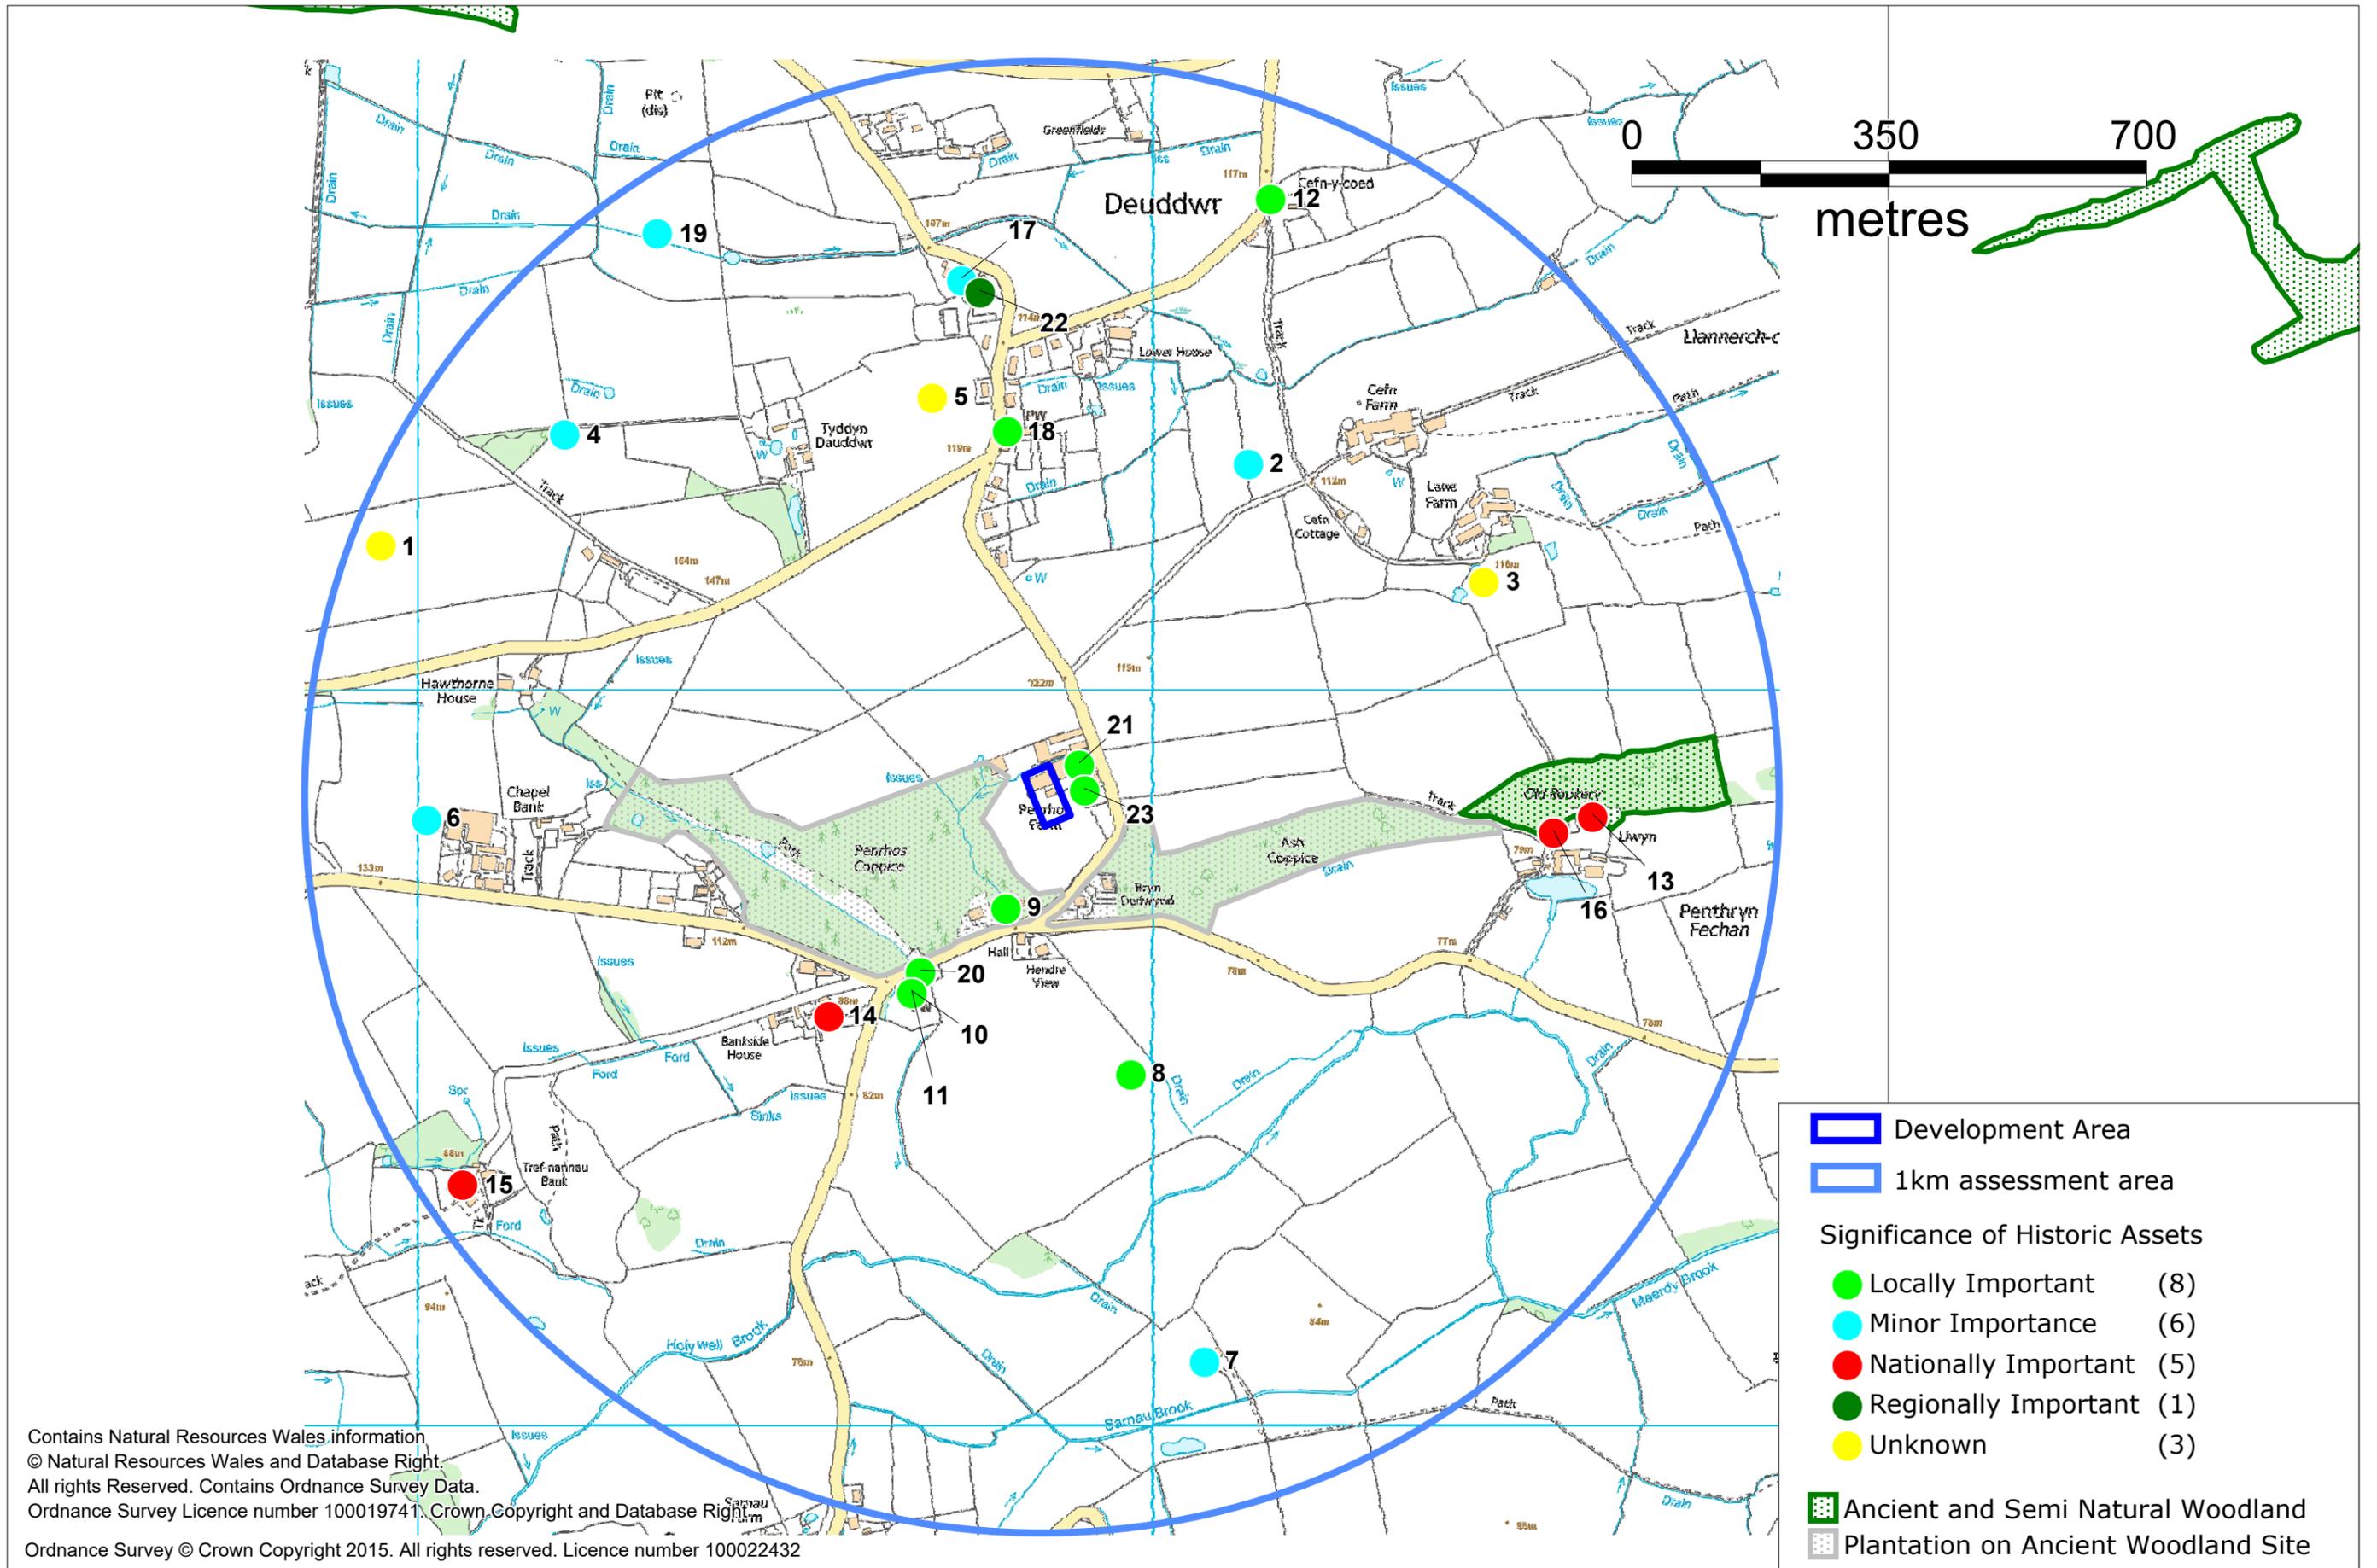
Figure 7: The 1km assessment area showing significance of historic assets, labelled with Project ID number

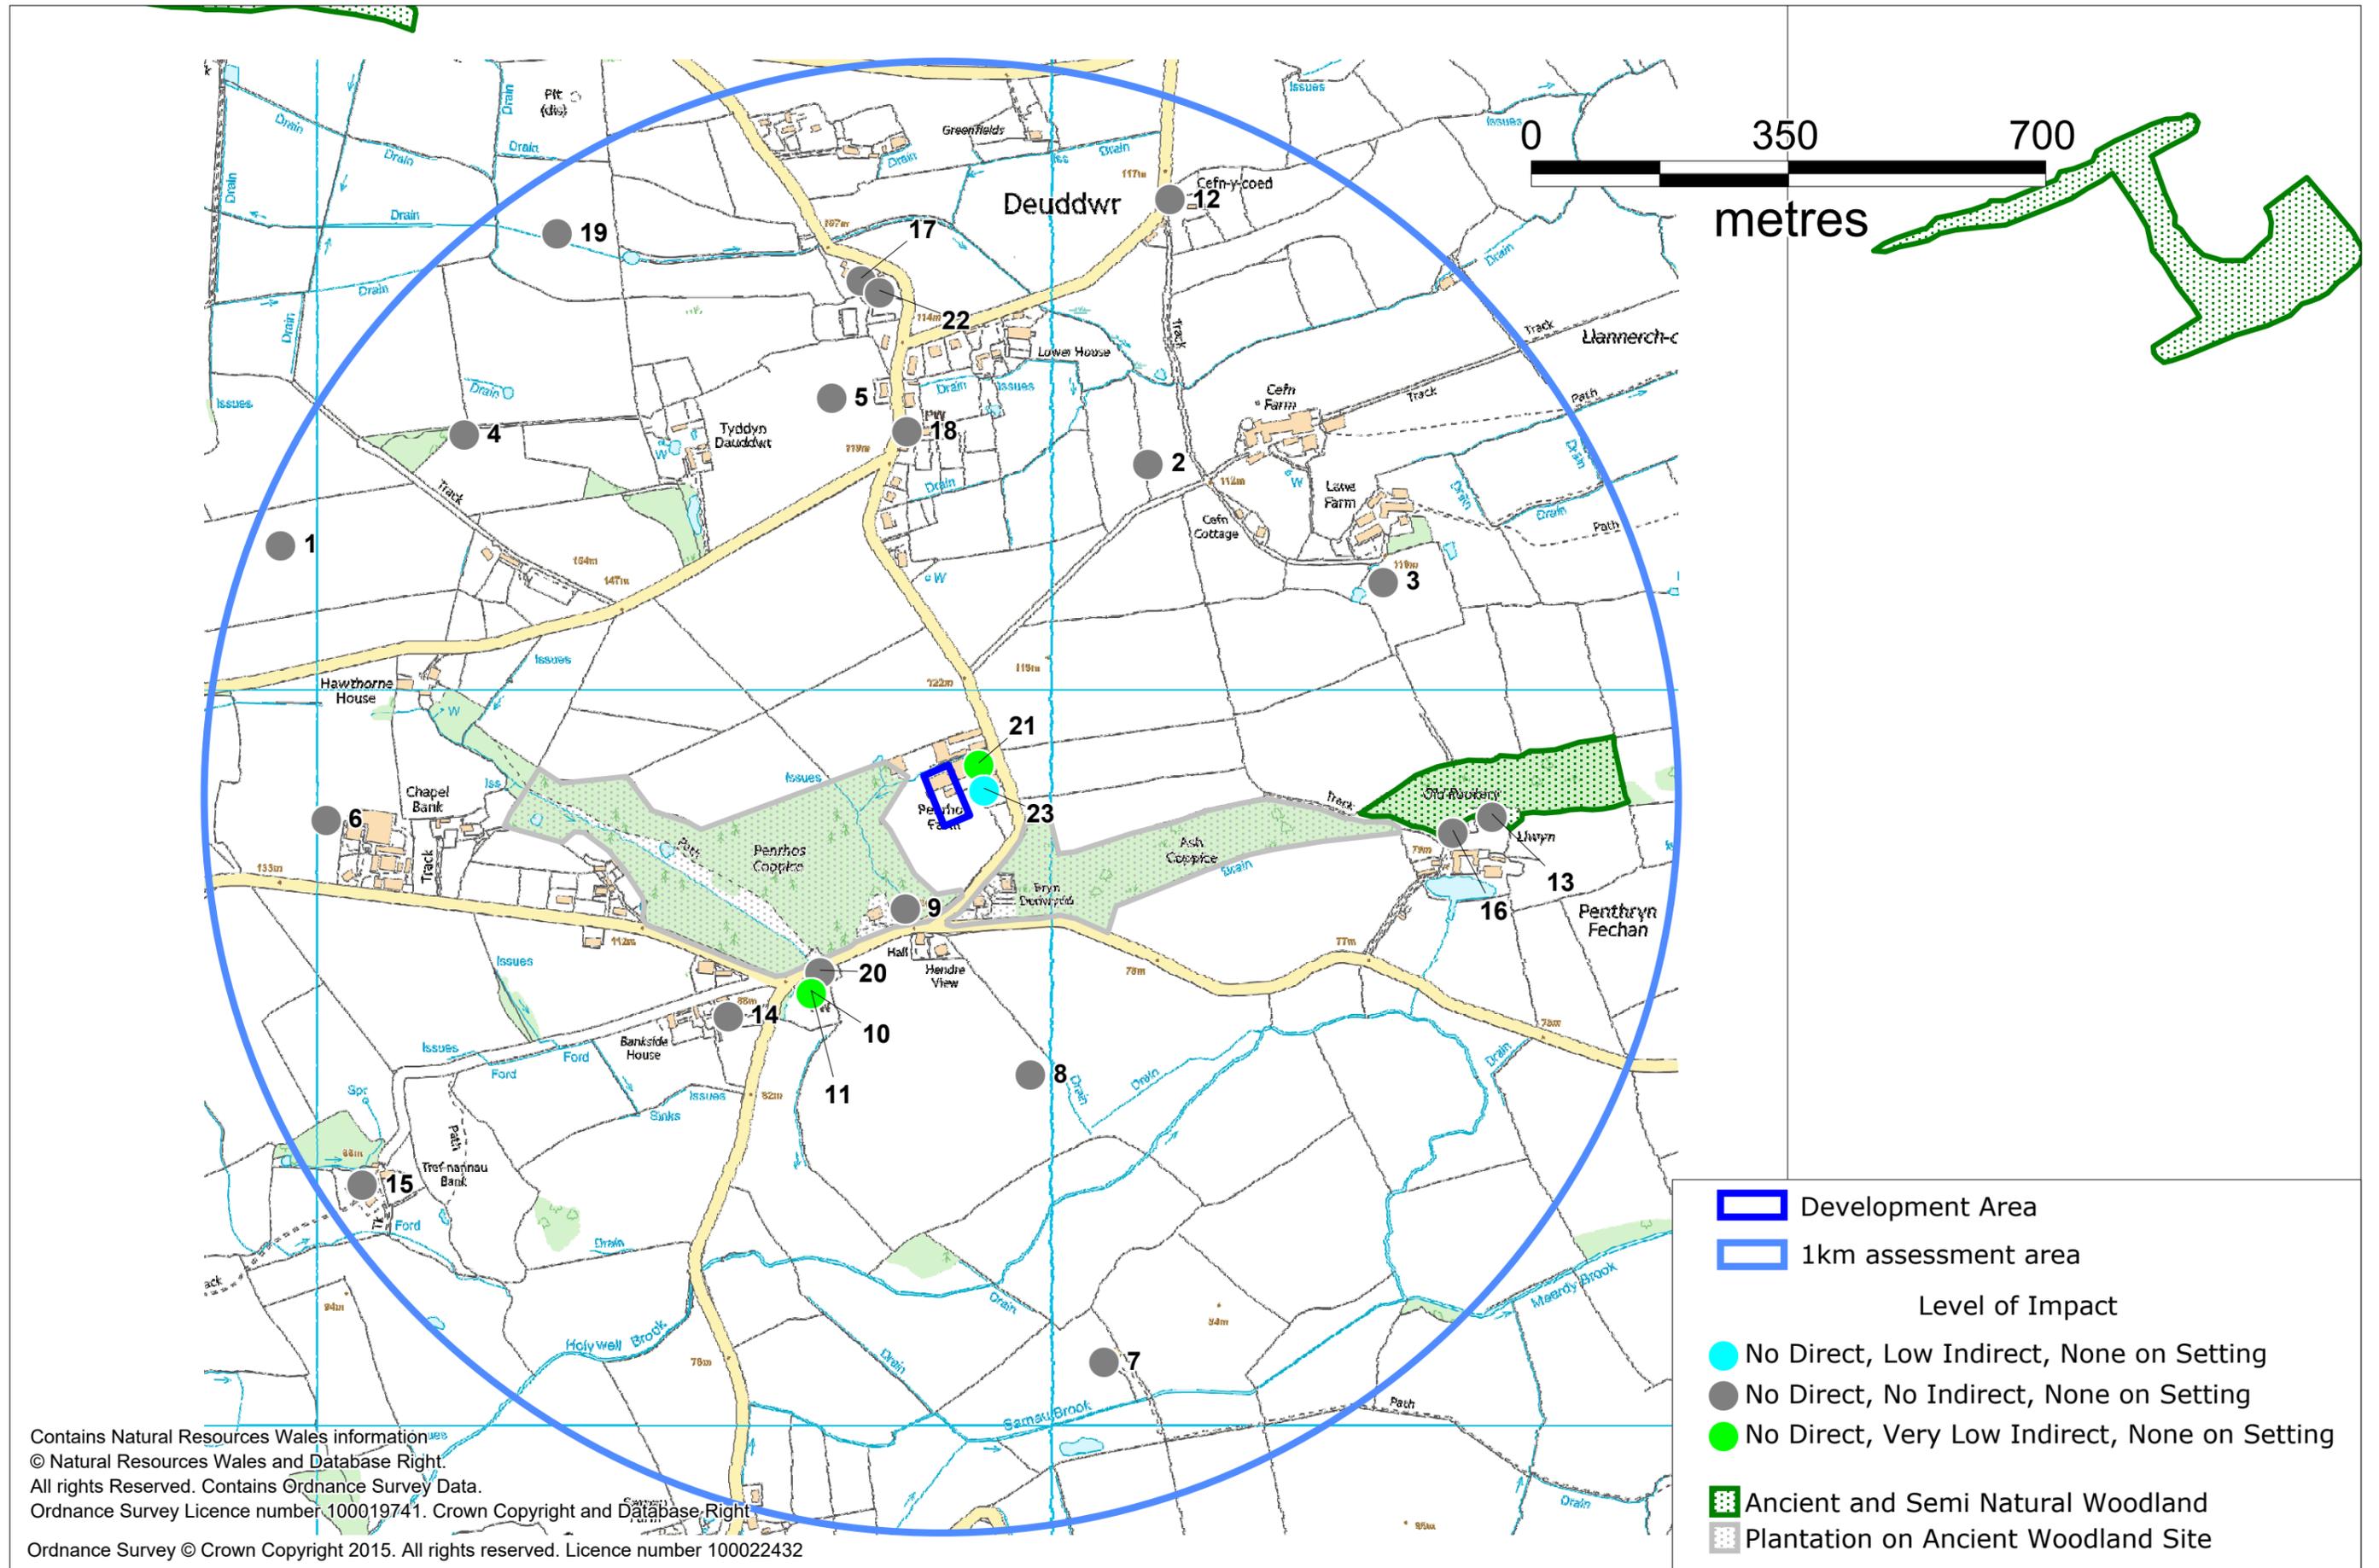
Figure 8: The 1km assessment area showing the impact on historic assets, labelled with Project ID number

11.1 The Direct and Indirect impact on each historic asset was assessed taking into account both physical and non-physical impacts, and whether the impact was Positive, Negative or Neutral. Each impact was assessed within the scale Very Low, Low, Moderate, High and Very High, taking into account the significance of the historic asset and the nature of the impact. A full table is found in Appendix B but a summary is tabulated in Table 2 below and illustrated in Figures 8 and 9.

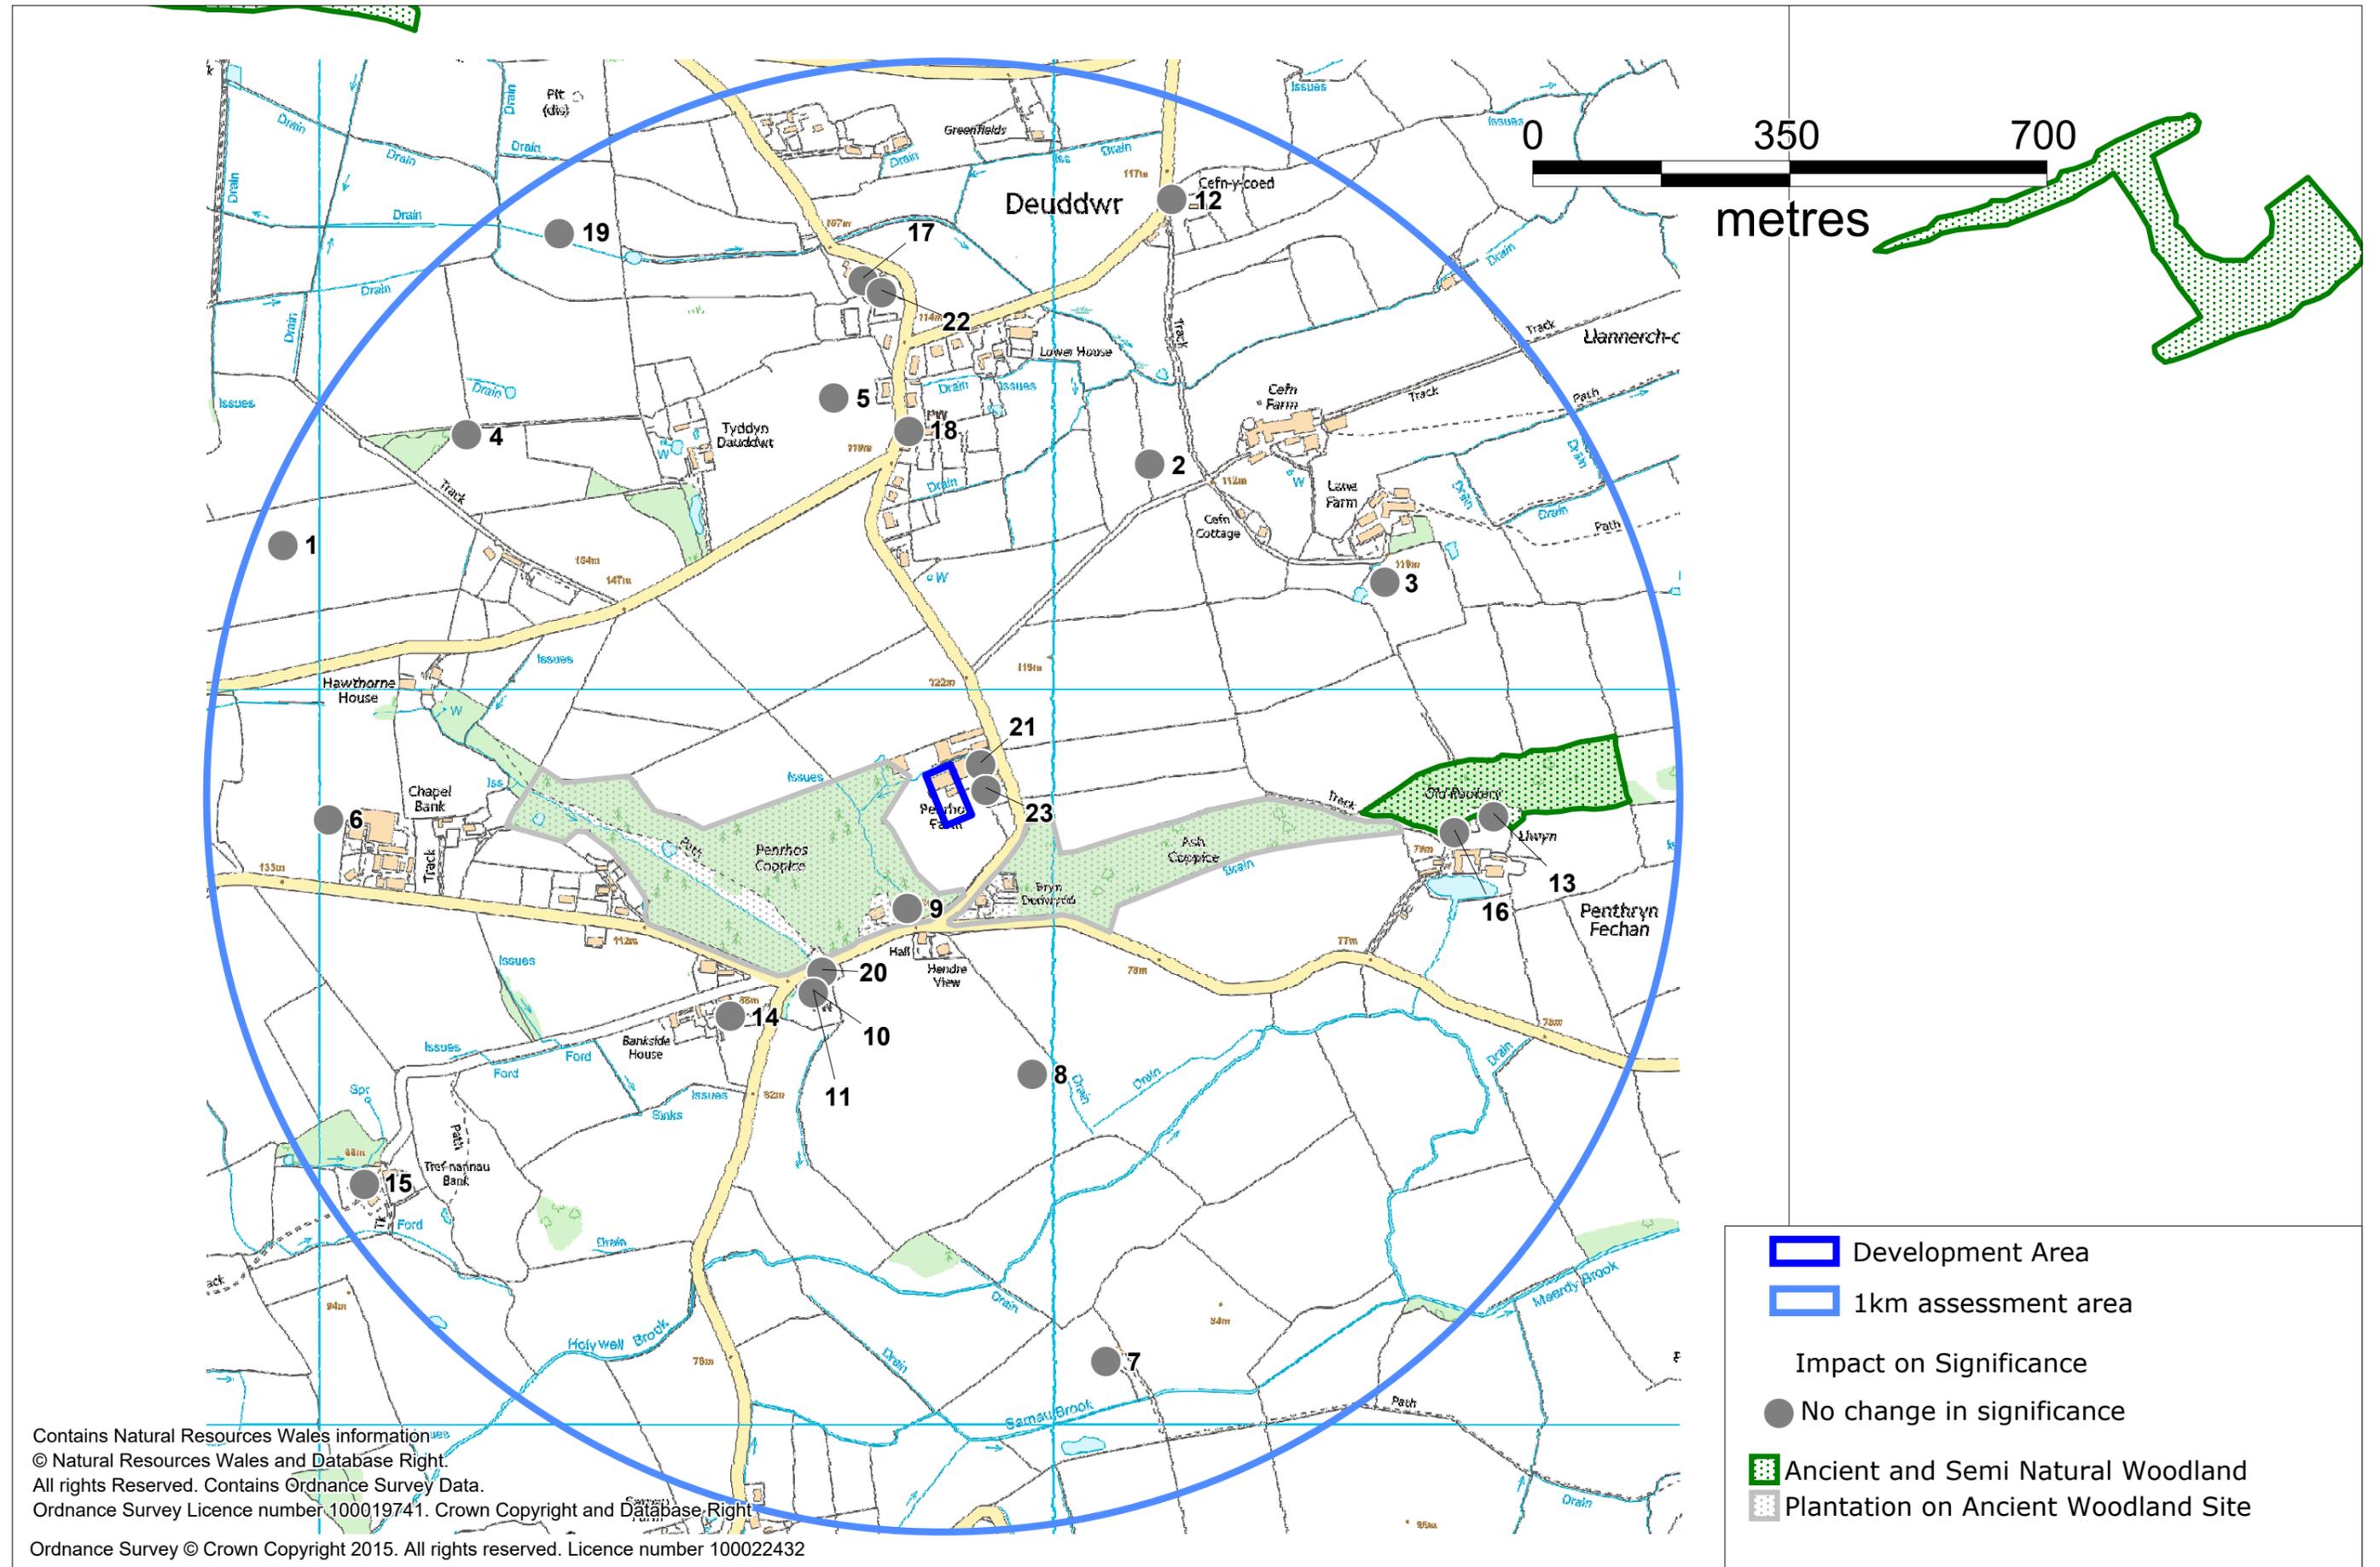
Figure 9: The 1km assessment area showing the change in significance of historic assets caused by the new development, labelled with Project ID number

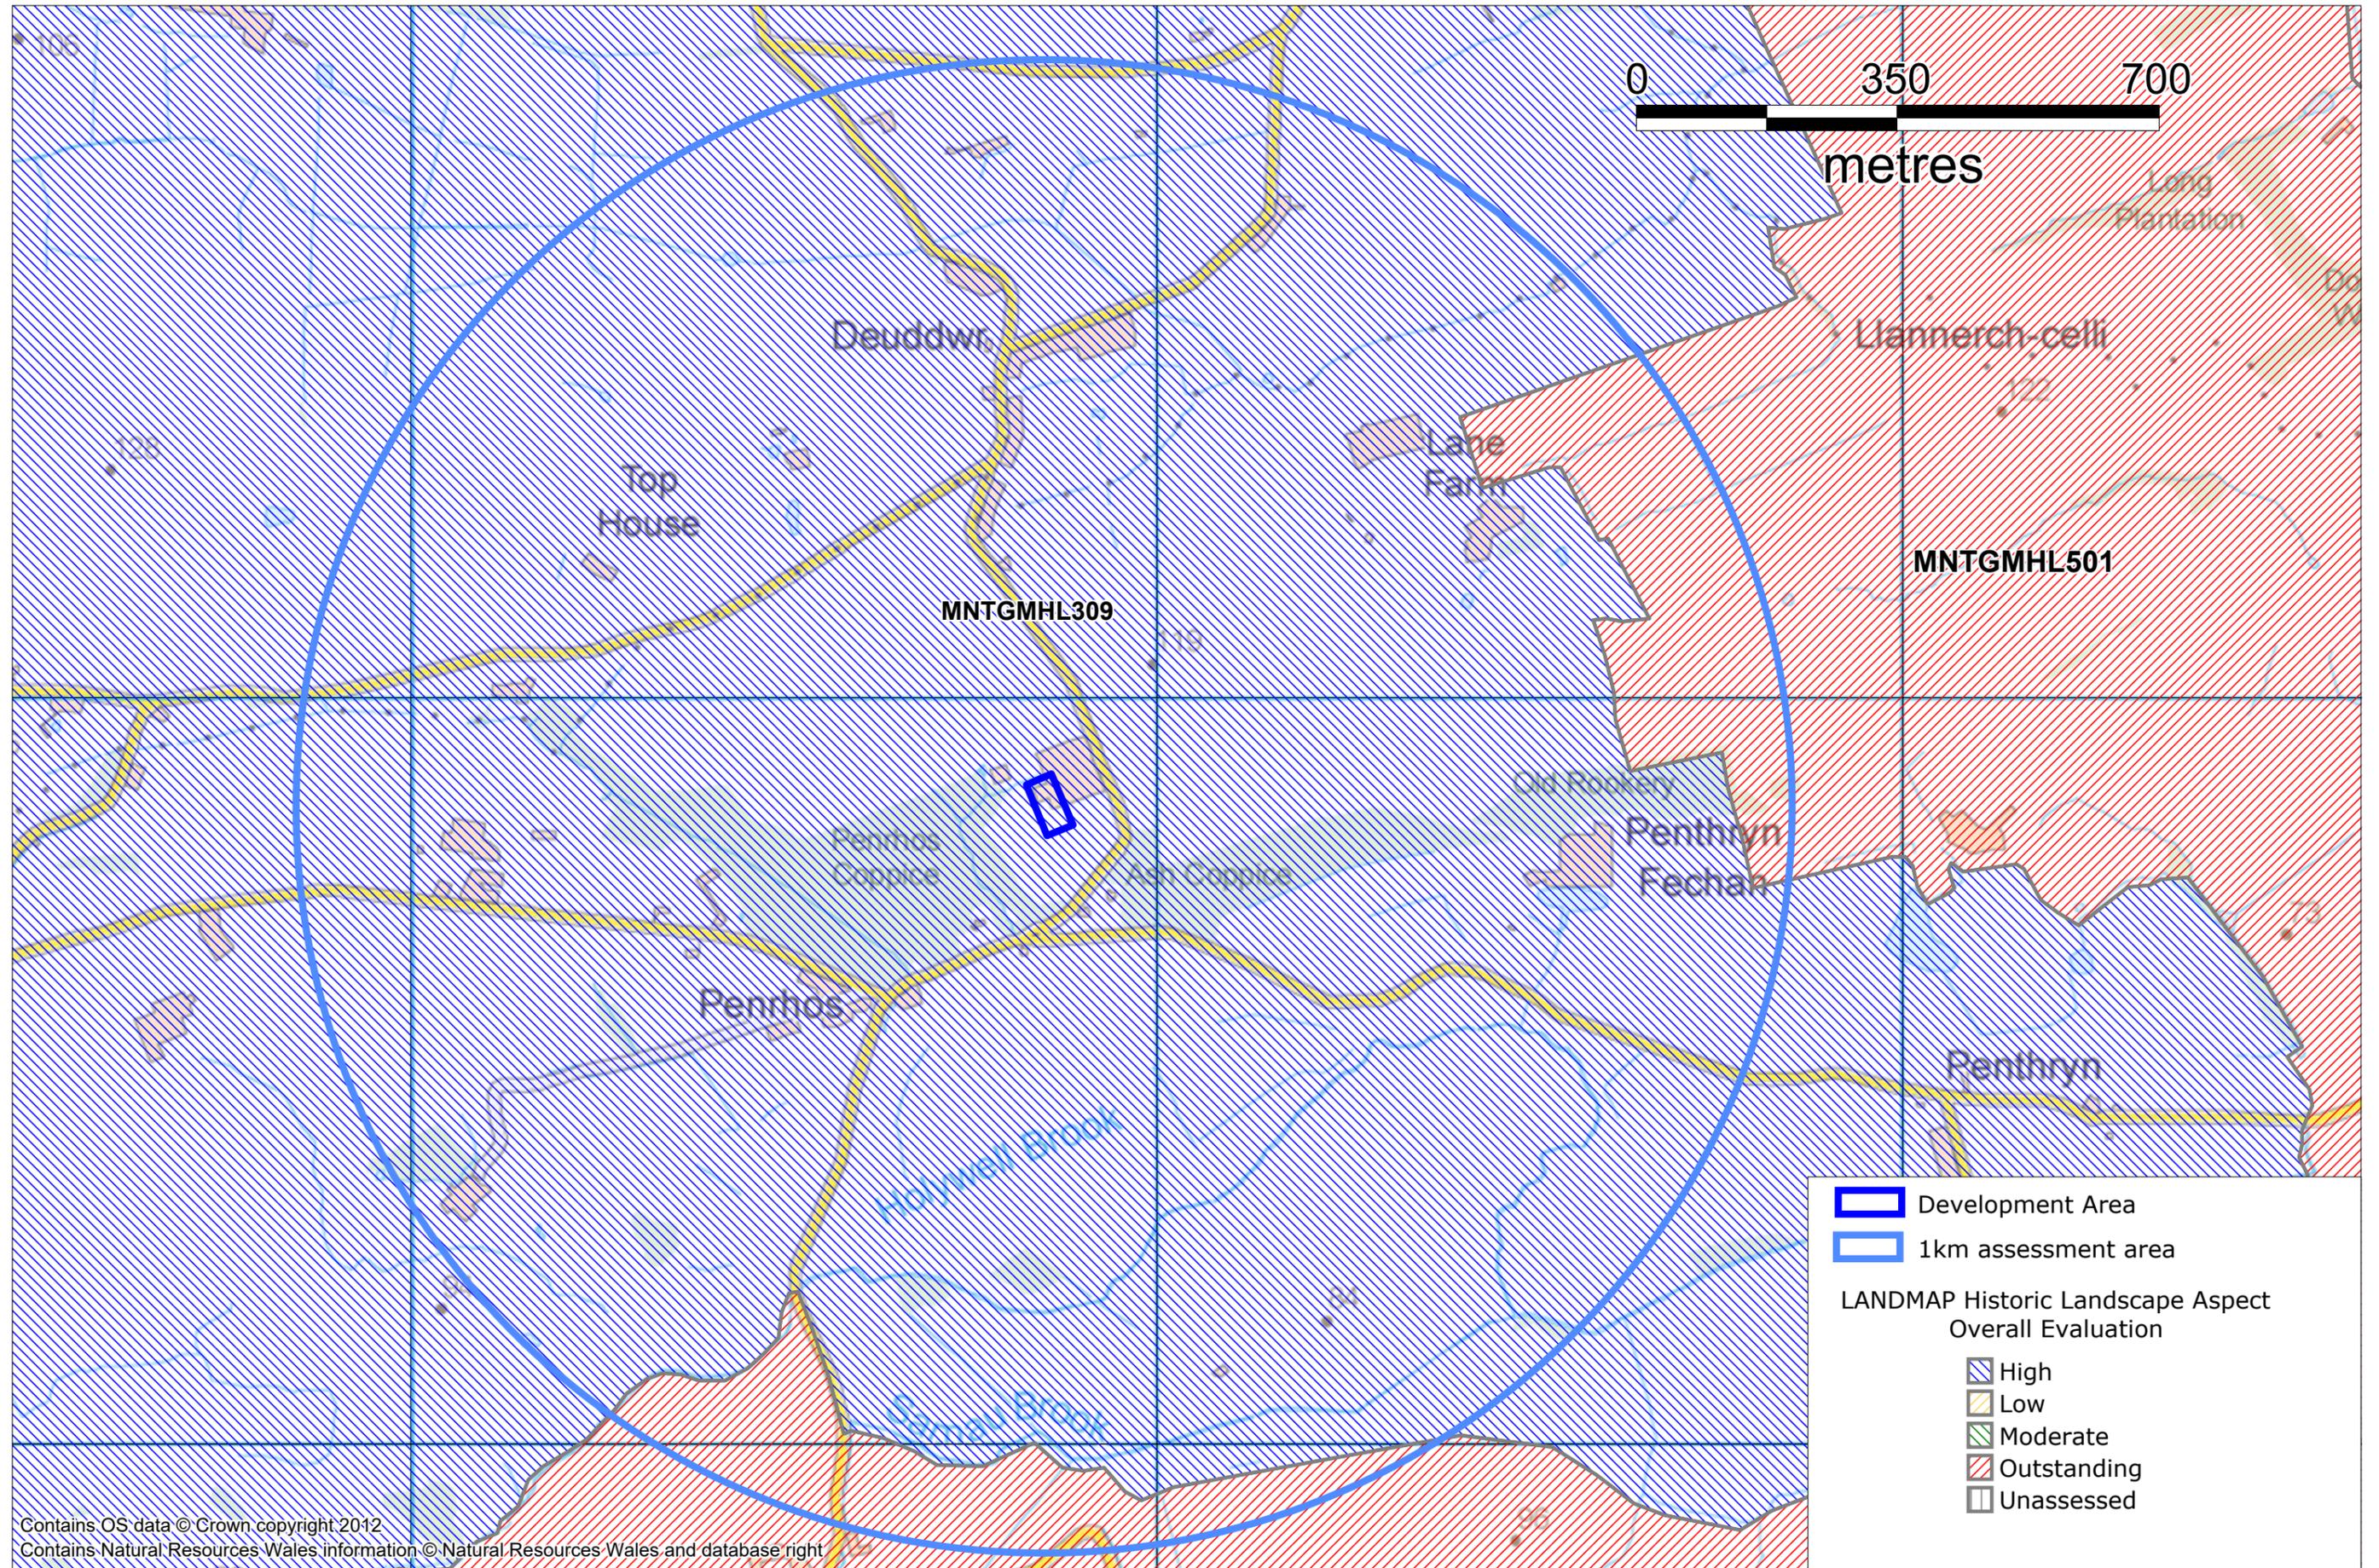
Figure 10: The 1km assessment area showing the LANDMAP Historic Landscape aspect, labelled with LANDMAP Aspect Area Numbers

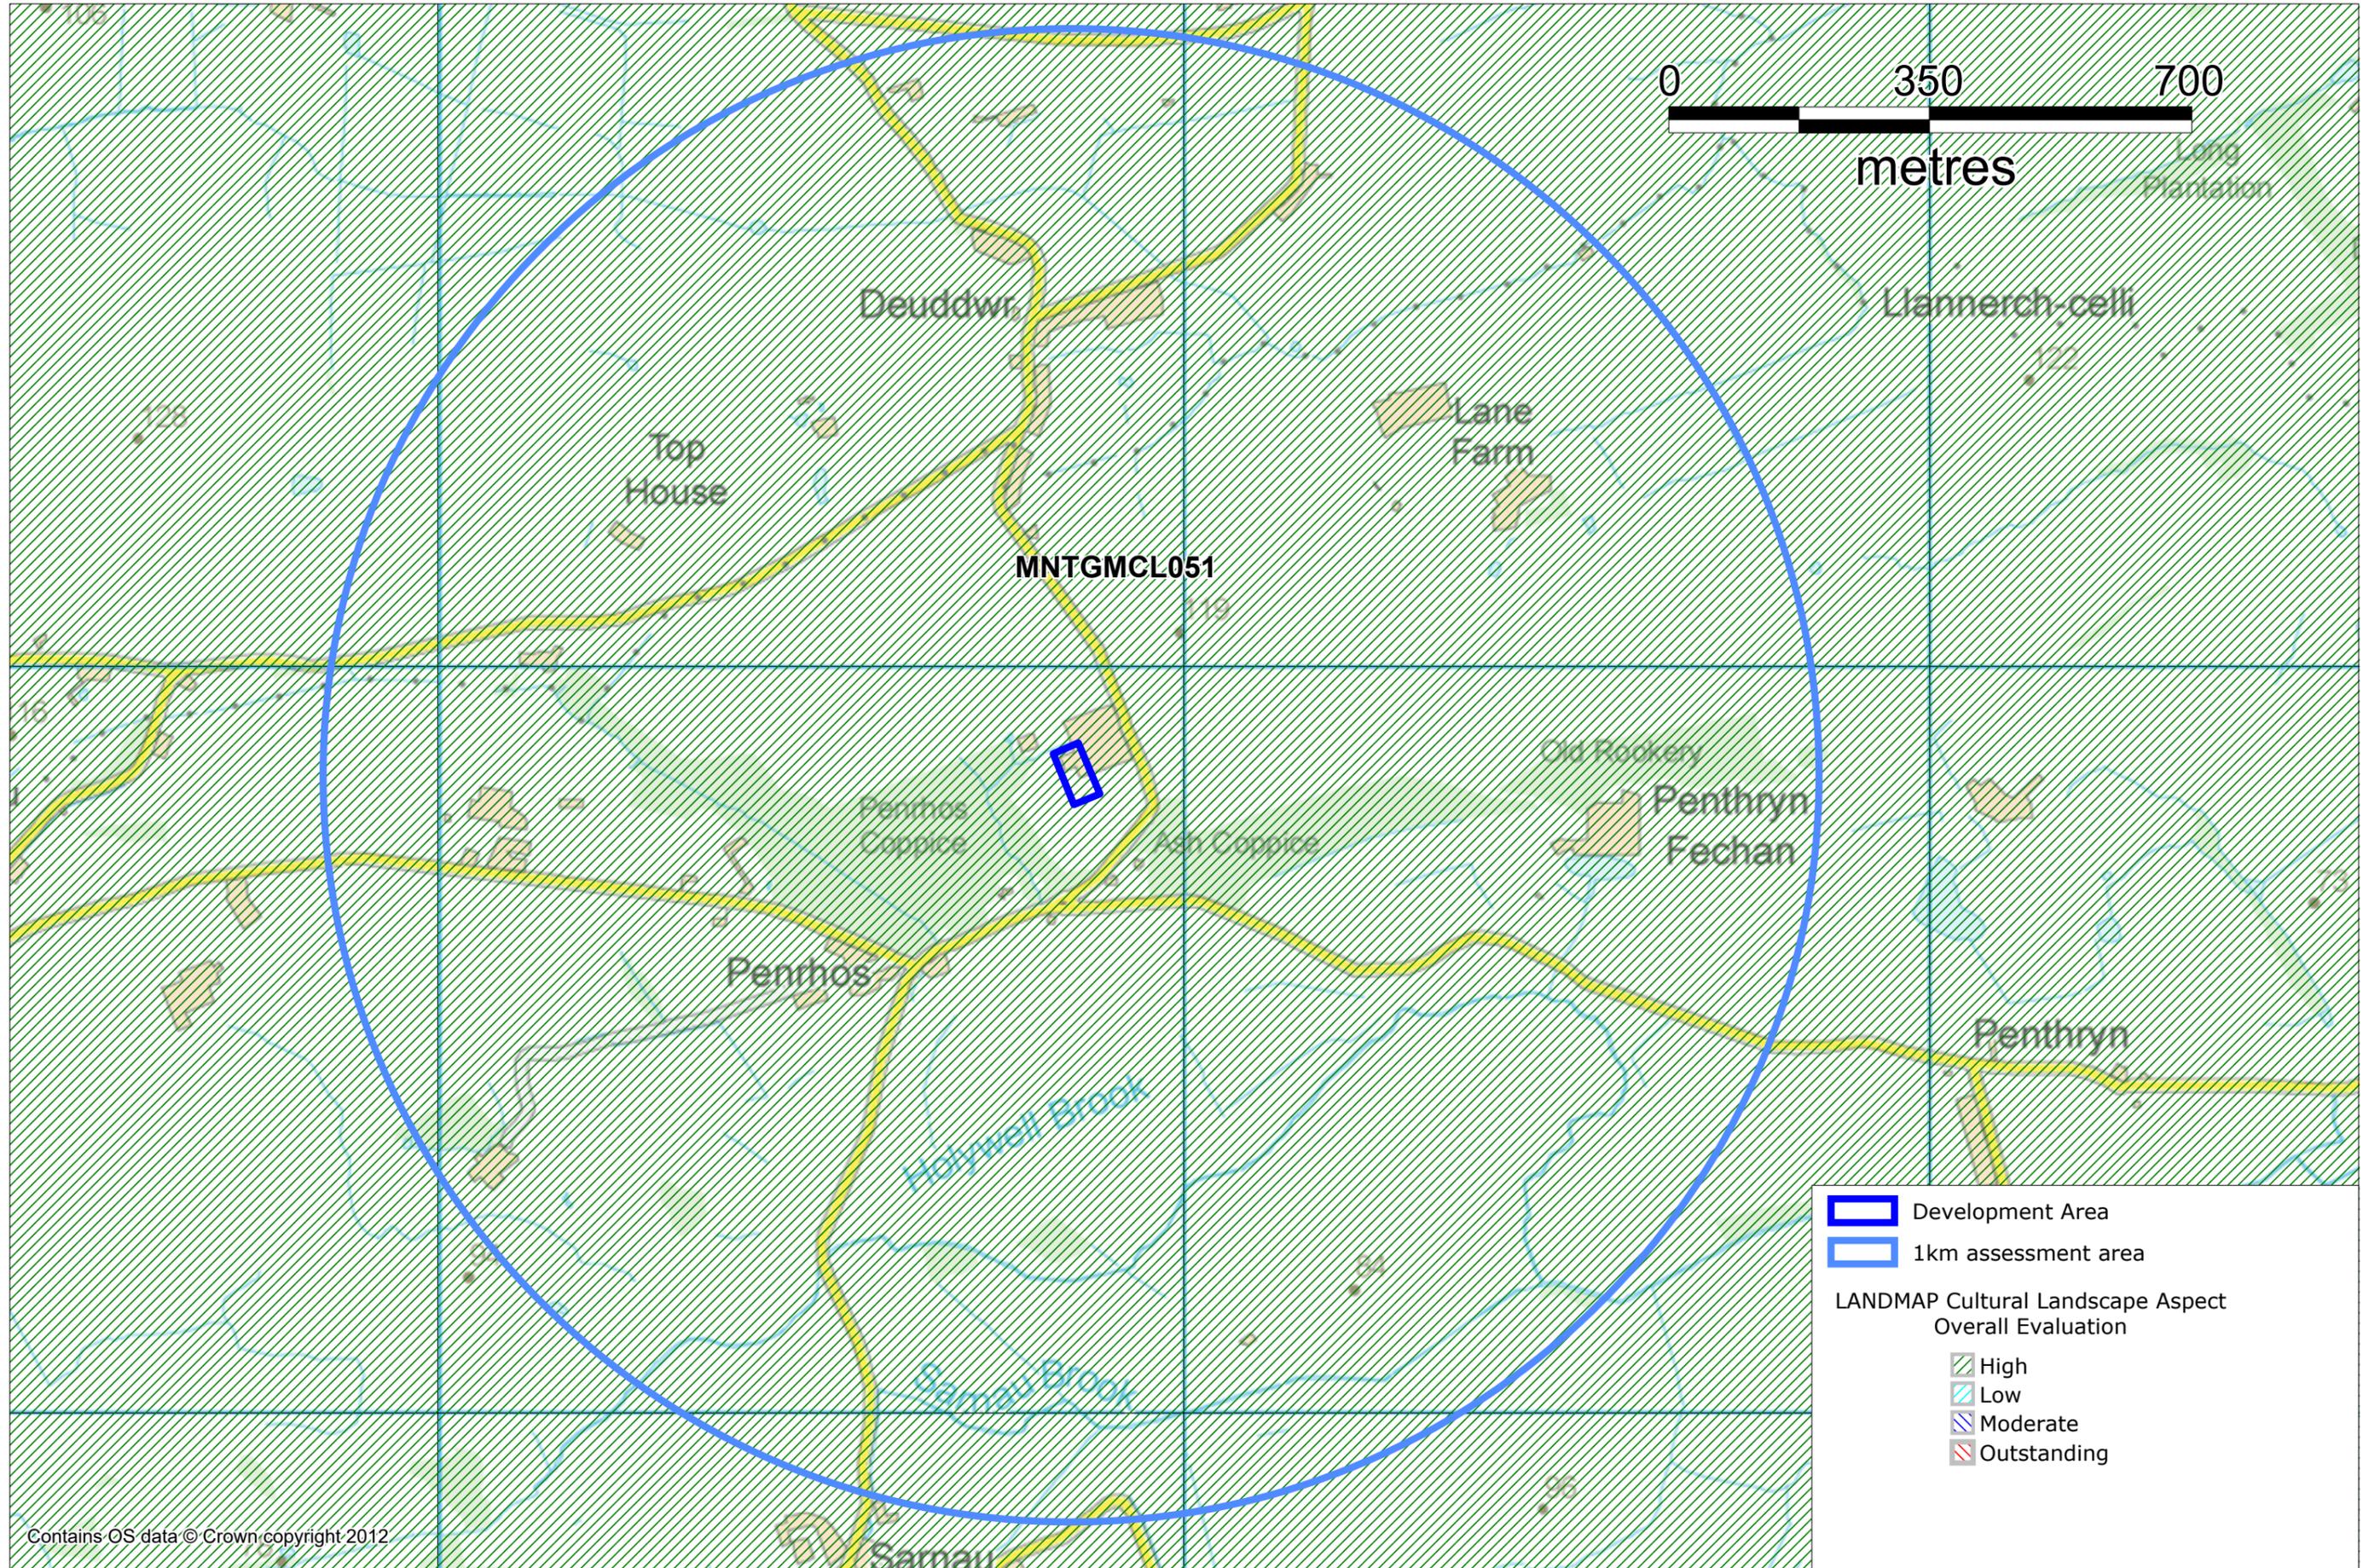
Figure 11: The 1km assessment area showing the LANDMAP Cultural Landscape aspect, labelled with LANDMAP Aspect Area Number
