New Storage Shed at Penrhos Farm, Penrhos, Llanymynech, Powys, SY22 6QH Desk-Based Assessment

For: Roger Parry & Partners

Trysor Project No. 2018/615

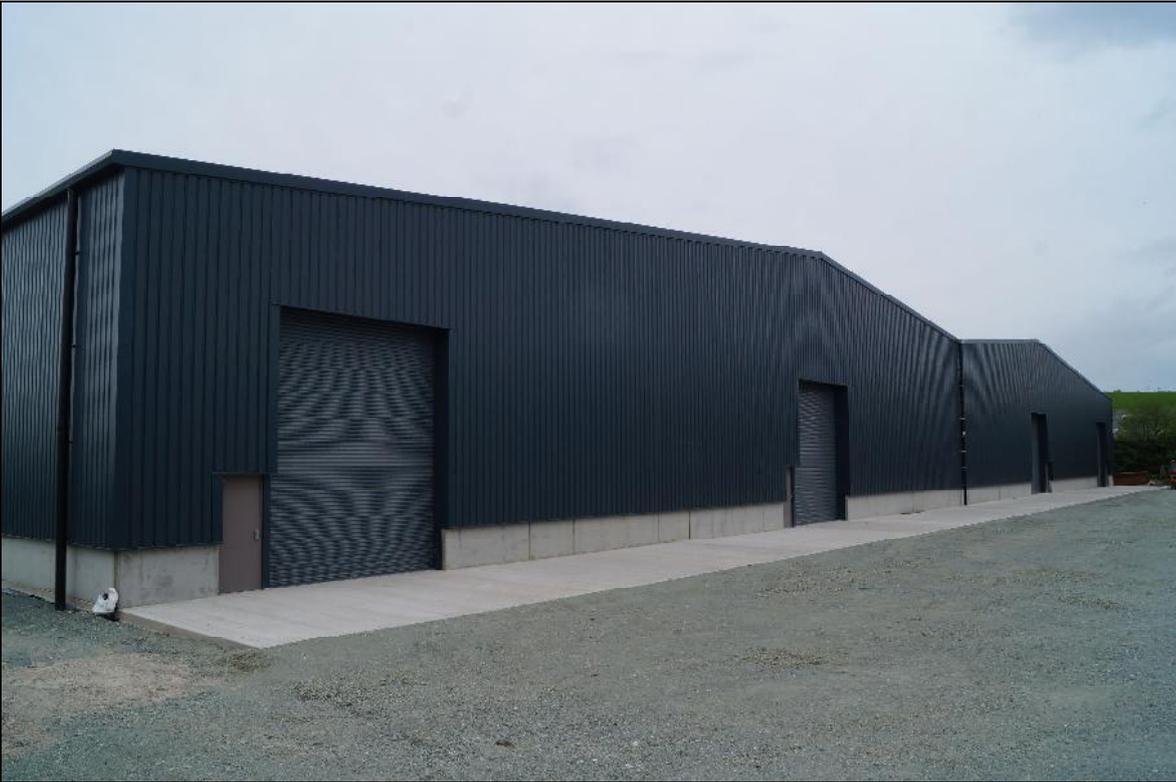
Plate 1: A view of the new storage shed, built to the west of the farmhouse and farm buildings at Penrhos Farm, looking northwest.

- 4.1 The development consists of a large storage building approximately 77 metres by 36 metres, and less than 10 metres high, with a yard to the east. An earth bund runs around the southern and western sides which has been planted with a double line of evergreen trees.
- 4.2 The southern part of the new storage building is within a former field, the northern part replaces a former agricultural shed.

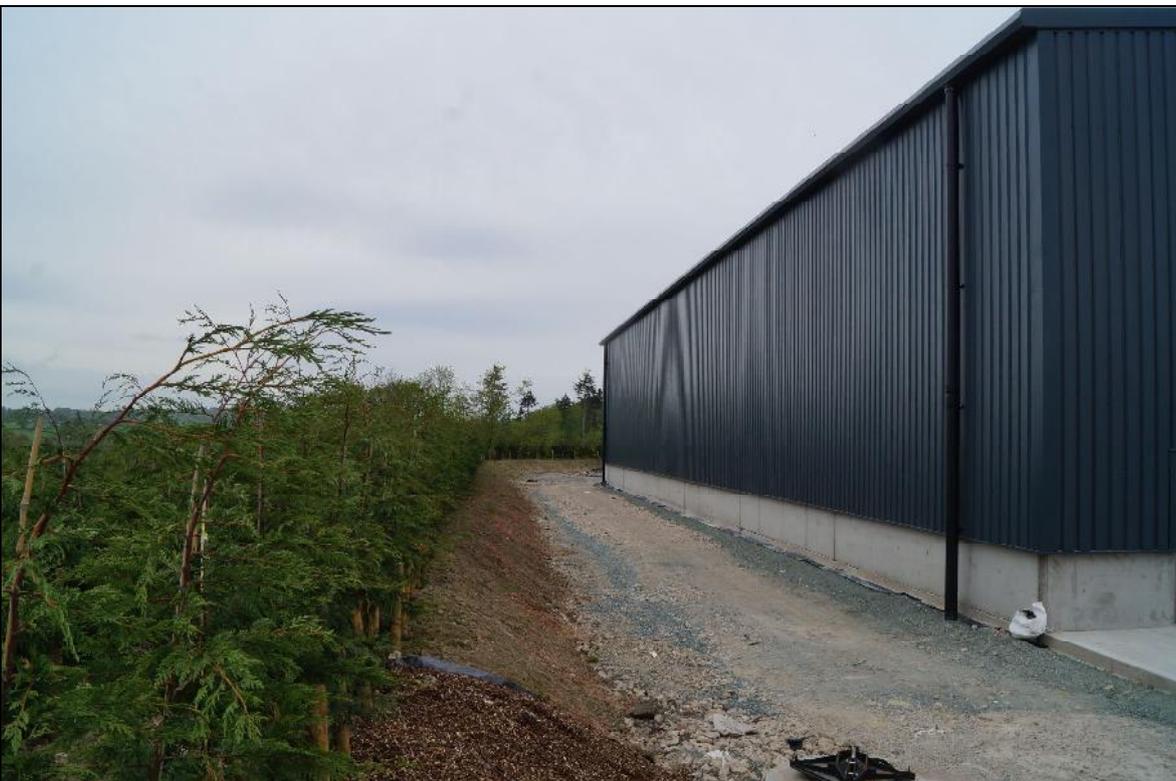
Plate 2: A view of the southern end of the new storage shed and the earth bund planted with two rows of evergreens, looking west southwest.

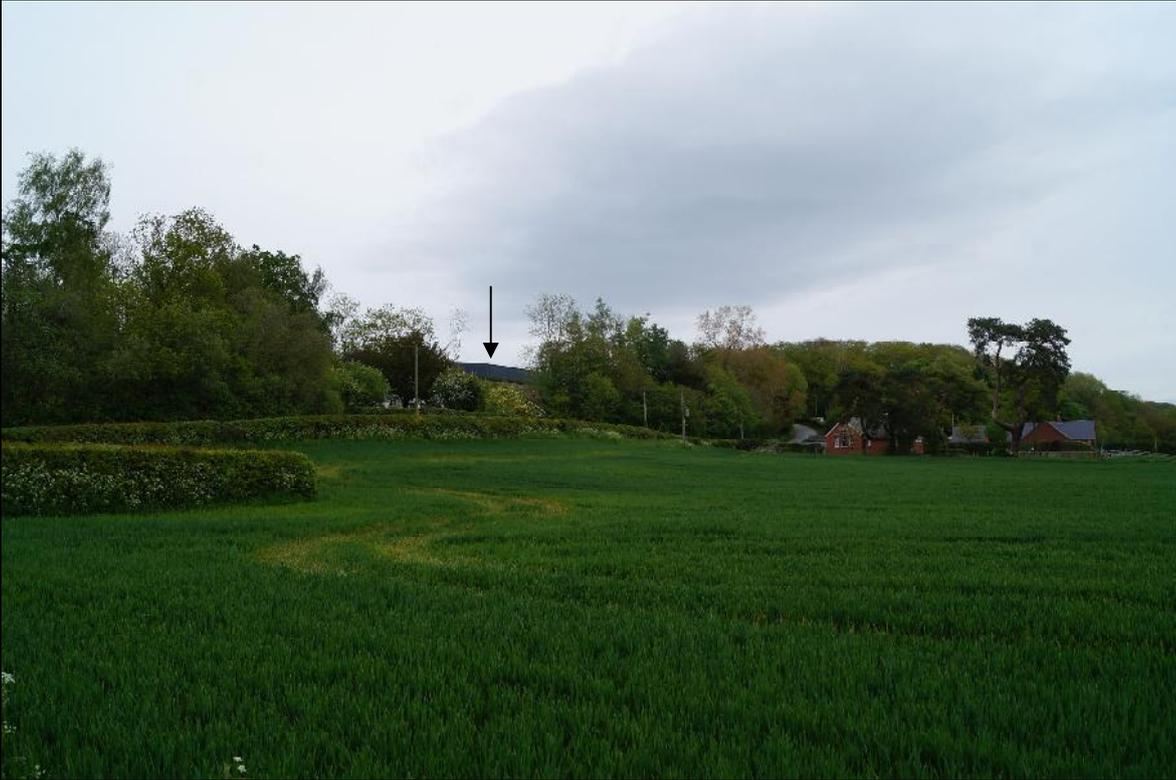
Plate 3: The view from the eastern edge of the churchyard ID number 11, looking northeast towards the new storage shed, indicated by the arrow.

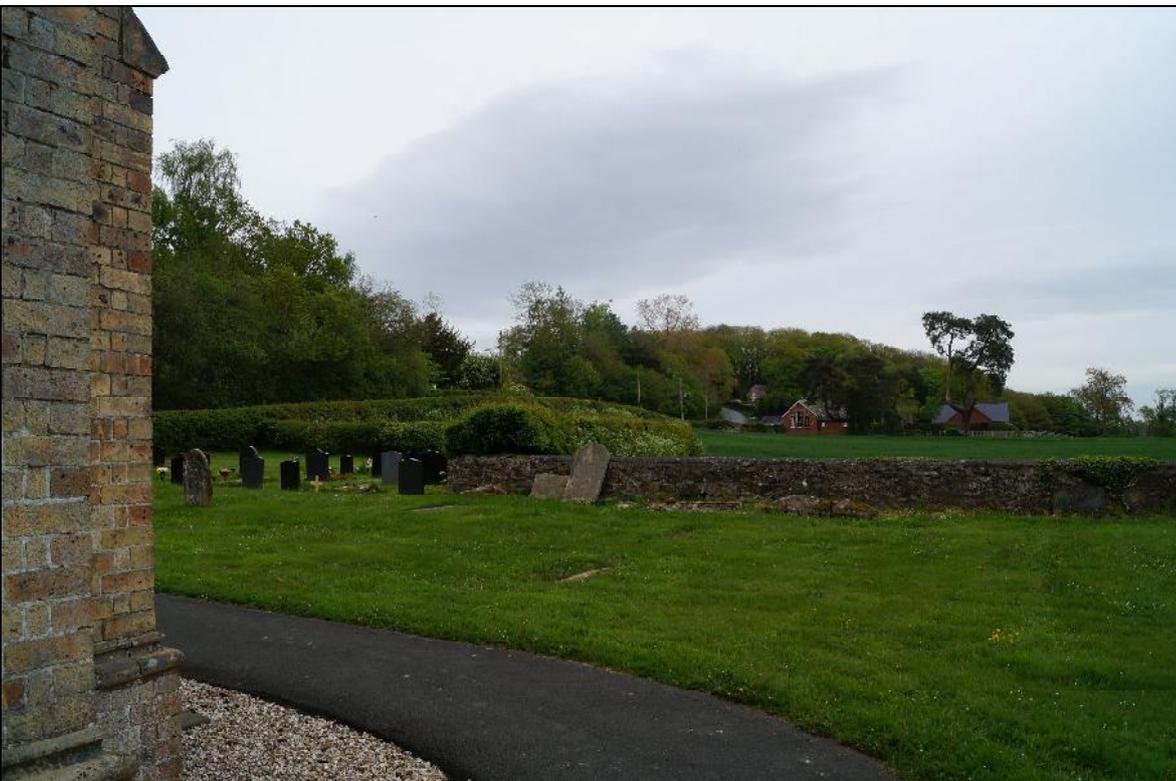
Plate 4: The view from ground level on the southern side of the church, ID Number 10, looking towards the new storage shed which is hidden behind trees.

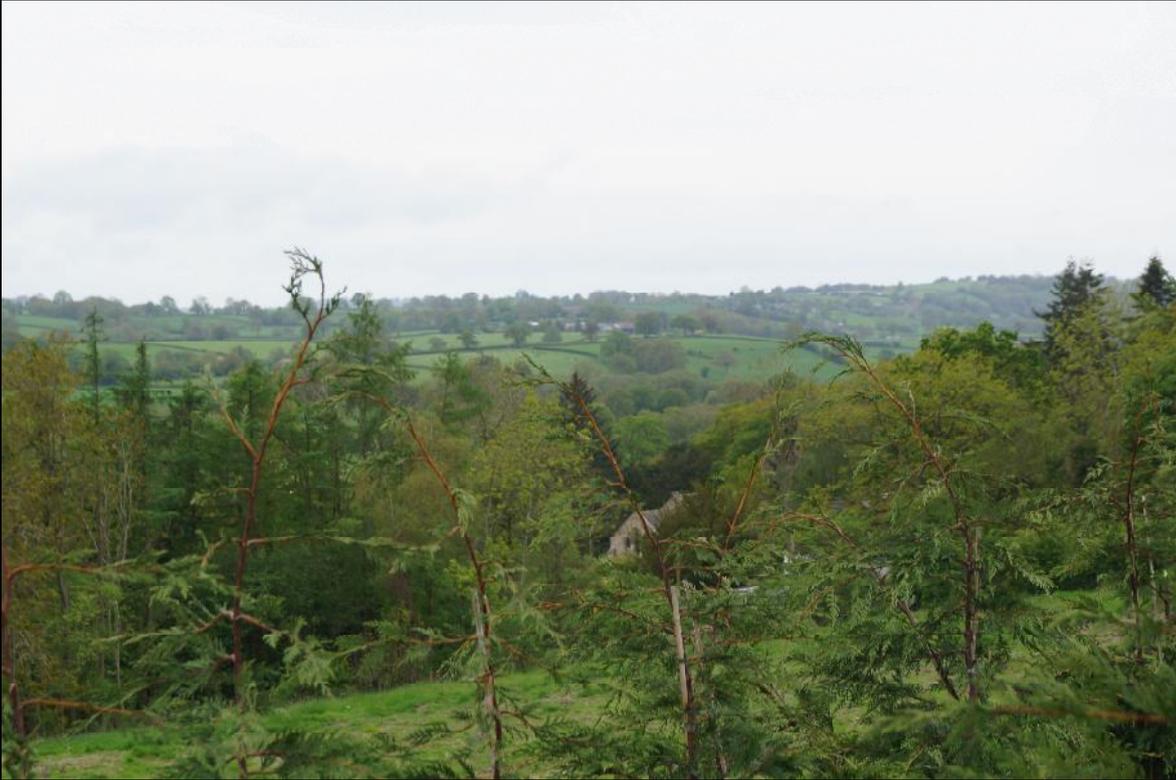
Plate 5: Partial view of the church taken standing on top of the earth bund to the south of the storage shed, looking southwest.

11.4 There are five Listed Buildings within the 1km assessment area. There has been a Very Low Negative, indirect, visual impact on Penrhos Church (ID Number 10) but with no impact on its setting and no impact on its significance, see Table 2, Appendix B and Figures 7, 8 and 9.

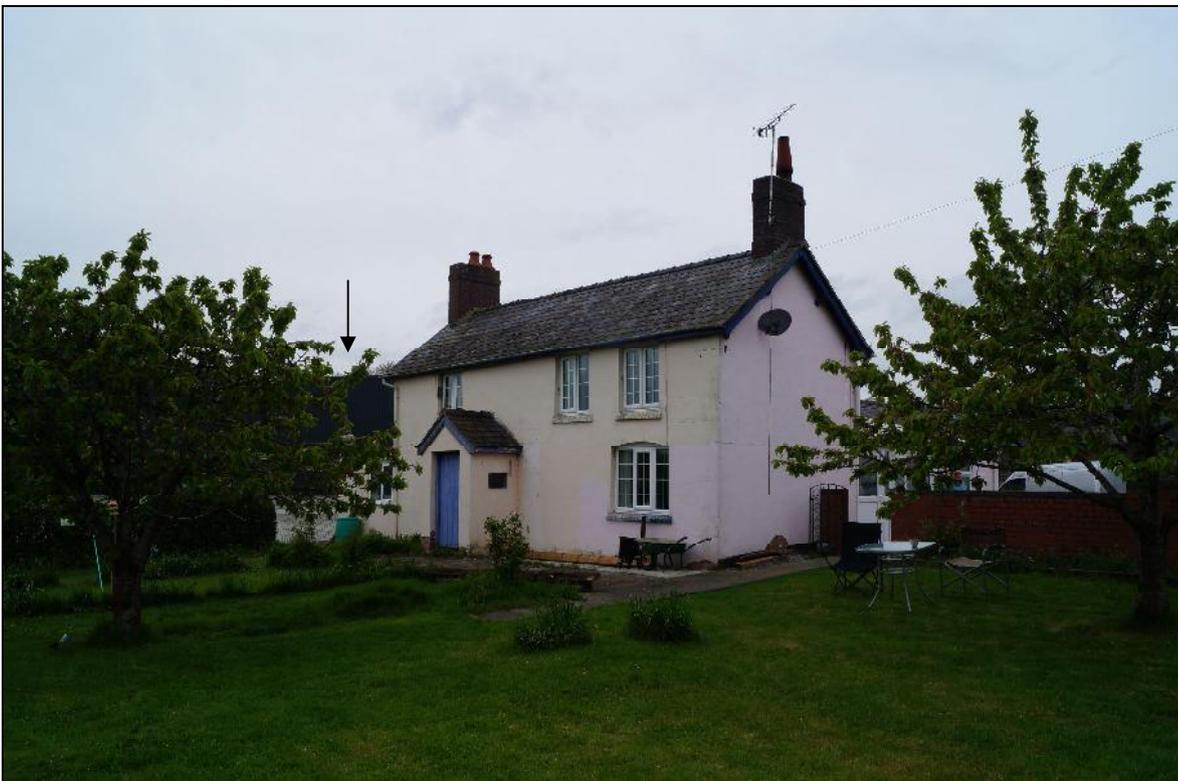
Plate 6: The farmhouse, ID number 23, at Penrhos farm, looking with the new storage shed behind.

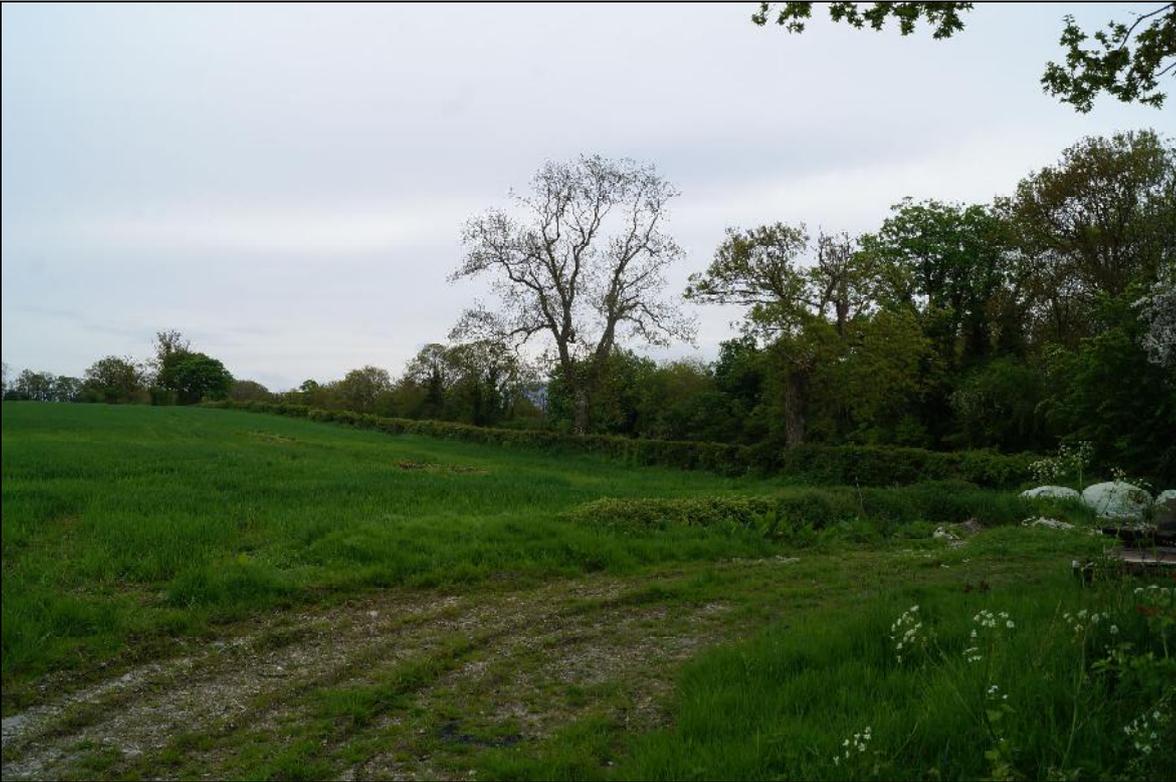
Plate 7: The view looking east towards the Listed Buildings at Llwyn which are hidden from view by topography and trees/vegetation.
