**HISTORIC ENVIRONMENT
DESK-BASED ASSESSMENT
FOR A STEEL FRAME BUILDING AND
HAULAGE YARD AT
PENRHOS FARM, PENRHOS,
LLANYMYNECH, SY22 6QH**

Report by: Trysor

Trysor Project No. 2021/781
CPAT HER Event Record PRN 164257

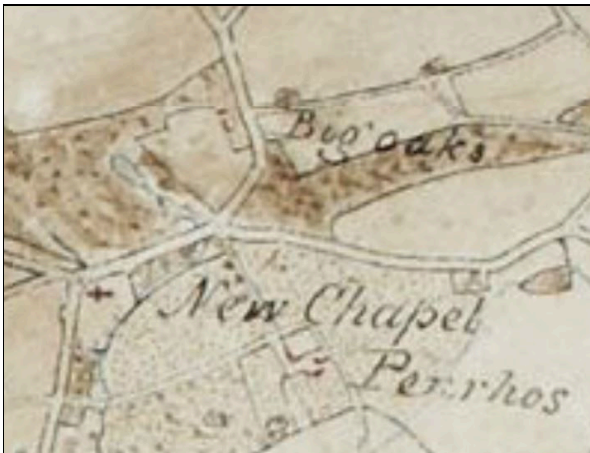
Figure 2: The 1829 Ordnance Survey Original Surveyors Drawing shows a building at the site of the present house at Penrhos Farm, apparently called Big Oaks at the time the map was prepared. There may be a second building to the north of the house.

- 8.2 The earliest map showing the property is the Ordnance Survey's Original Surveyors Drawings, Meifod sheet, surveyed in 1829, see Figure 2. The Original Surveyors Drawings represent the first detailed map series of the whole country. They do not generally map field boundaries in detail although some basic details of the field system are shown on the 1829 map for the area around Penrhos Farm. A building appears to be shown at the site of the house on this map, which it names as "Big Oaks." There may be a second building to the north of the house but the map is indistinct.

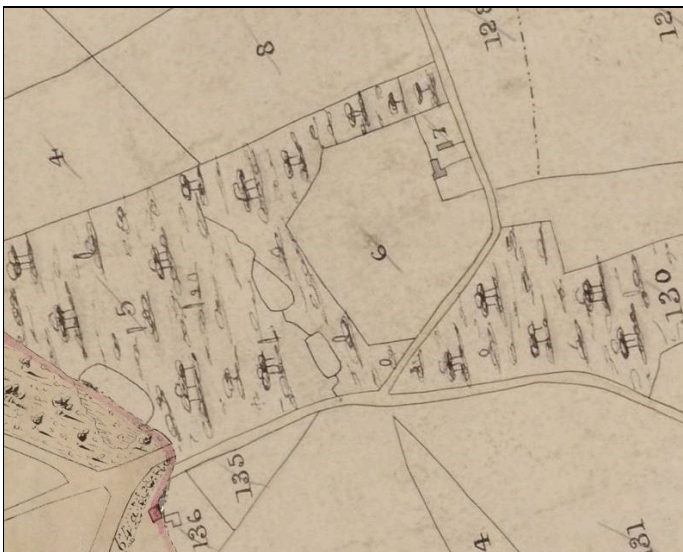
Figure 4; An excerpt from the Llandrinio parish tithe map of 1841. The development site falls within field parcel number 6, which was a field known as Big Oak field on the tithe schedule.

8.4 The Llandrinio parish tithe map of 1841 is the first detailed map of the field system of the area, see Figure 4. This map is the first to show a clear depiction of the layout of the farmyard buildings at Penrhos Farm. It shows the T-shaped house in its present position, with a single, rectilinear outbuilding to the northwest and a smaller outbuilding to the north. The present house may incorporate parts of the house shown on this map. The majority of the development site falls within field parcel number 6, which is named as "Big Oak Field" on the tithe schedule. The current haulage yard area was wooded and part of Chapel Bank Plantation, field parcel 5.

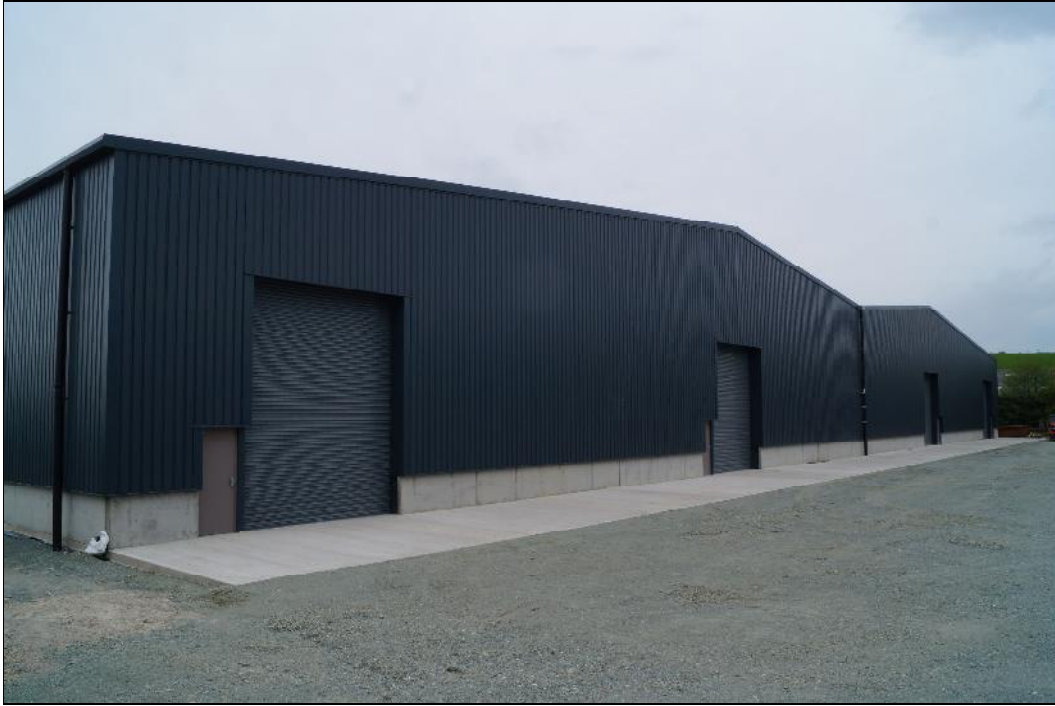
Plate 1: A view of the new storage shed at Penrhos Farm, painted dark blue-grey, May 2018. Looking northwest.

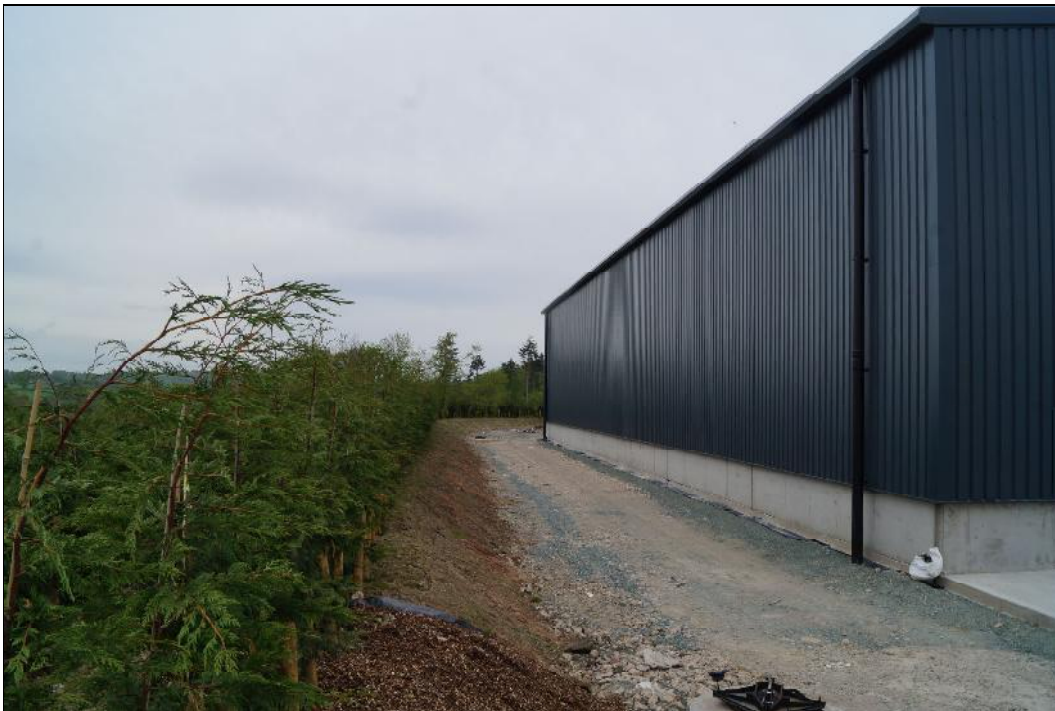
Plate 2: A view of the southern end of the new storage shed, in the original dark blue-grey, showing the earth bund planted with two rows of evergreens as they appeared in May 2018. Looking west-southwest.

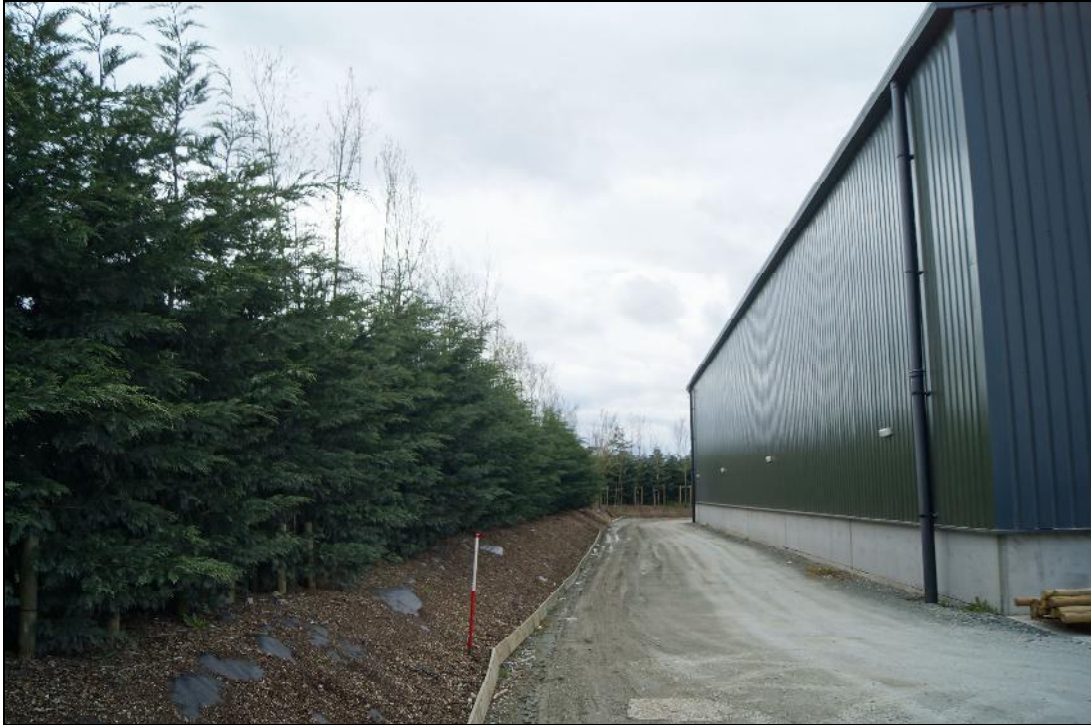
Plate 3: A similar view of the southern end of the new storage shed, now repainted in green. The leylandii screening hedge has grown significantly since 2018 and been strengthened by deciduous trees planted along the top of the bund. Looking west-southwest.

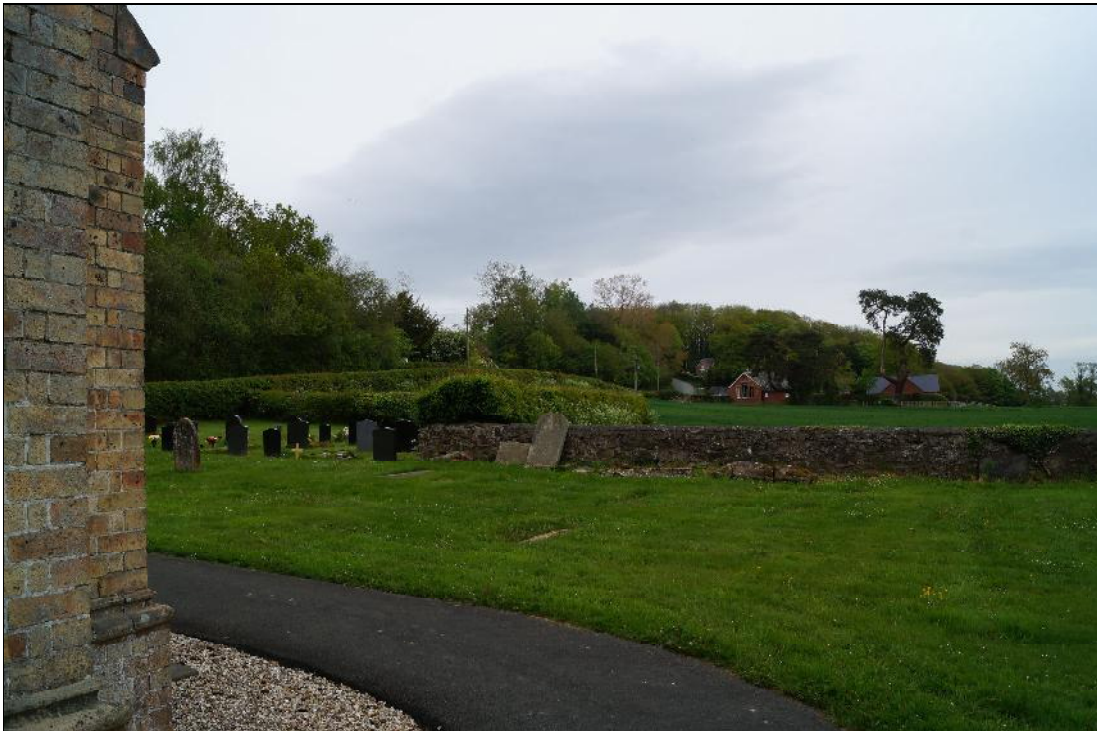
Plate 4: The view from ground level on the southern side of the church, taken in May 2018, looking in the direction of the new storage shed which is hidden behind trees. Looking northeast.

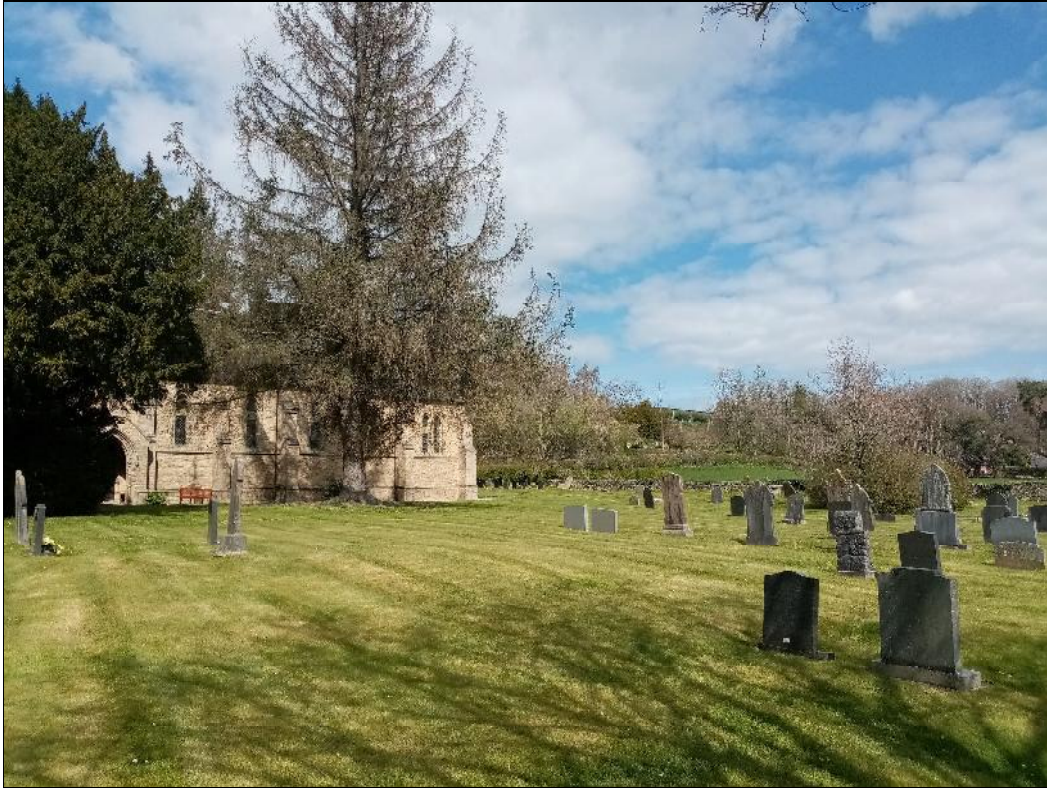
Plate 5: A view from the southern side of the churchyard in April 2021. The shed is partially visible in this image but the maturing of the screening hedge and addition of deciduous trees in front of the shed, and the repainting of the shed in green, has reduced the visible impact on the setting of the church. Looking northeast.

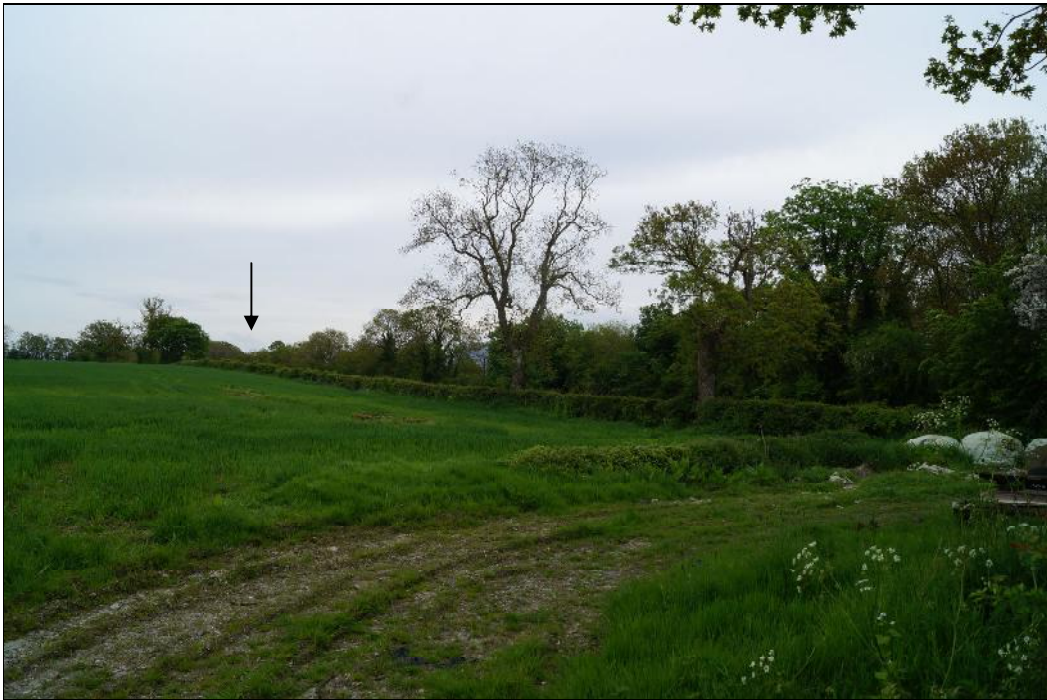
Plate 6: The view looking towards the Listed Buildings at Llwyn Farm (ID number 28) which are completely hidden from view by topography and trees/vegetation. Looking east.

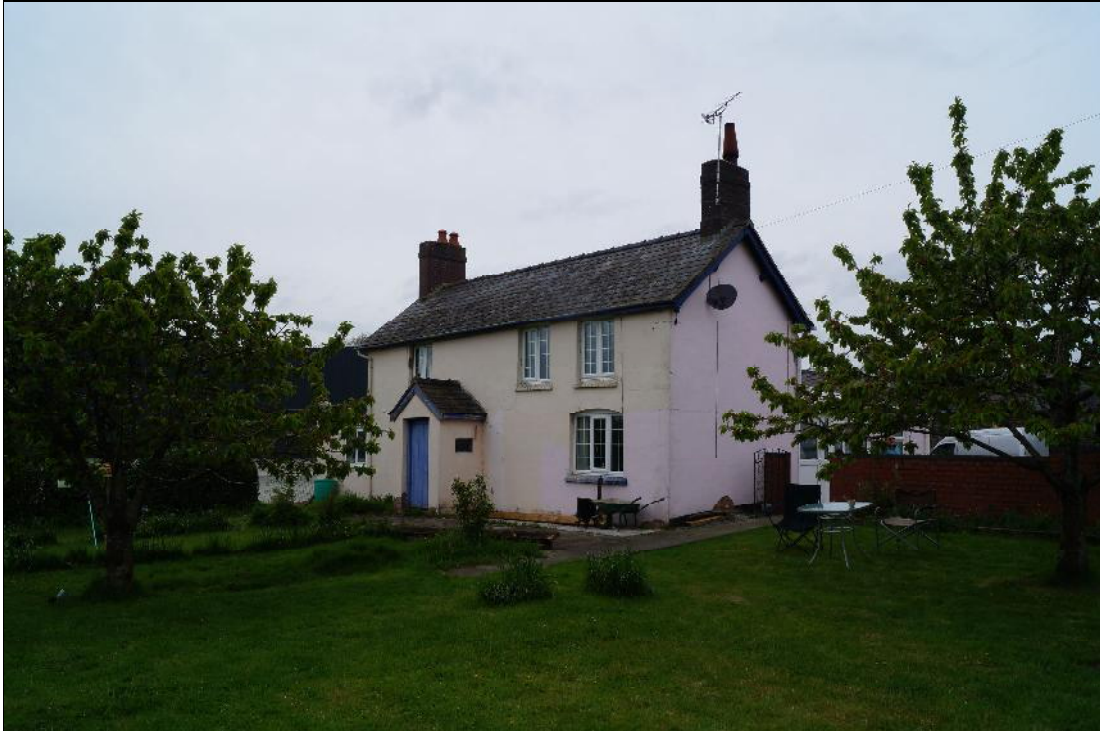
Plate 7: The farmhouse at Penrhos farm (ID number 22), 2018, with the new storage shed just visible behind. Looking northwest.

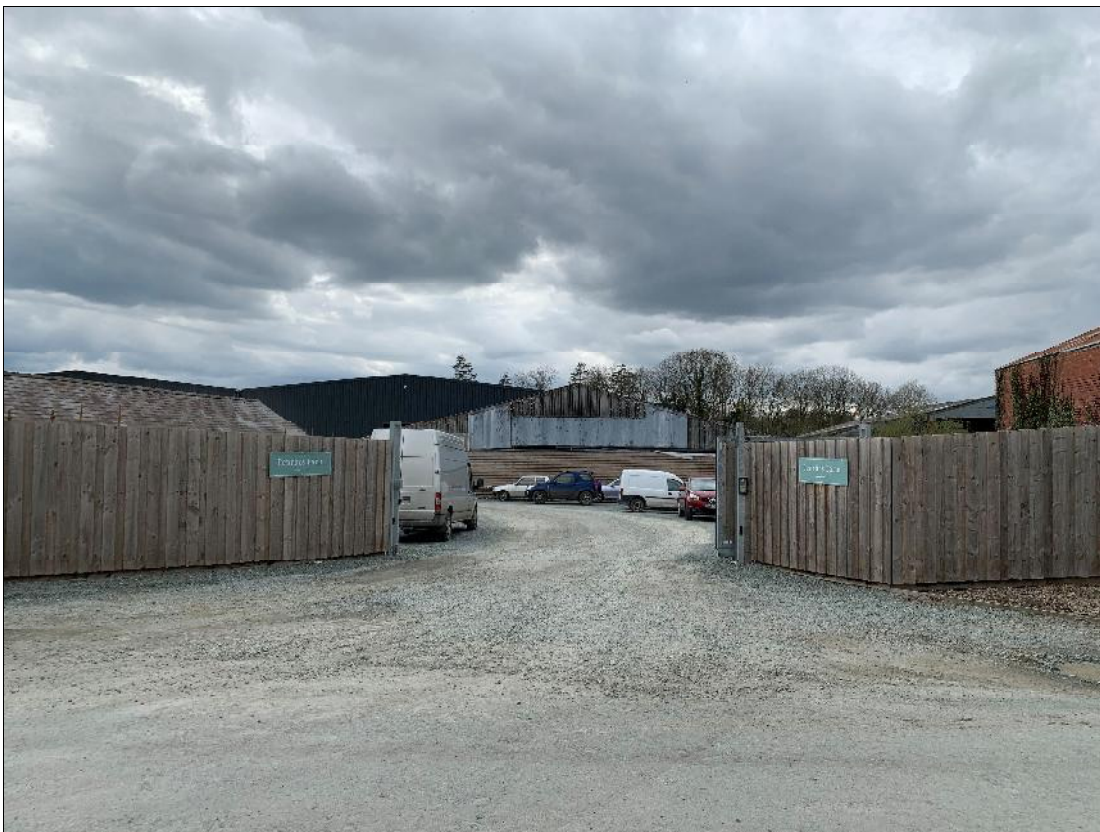
Plate 8: A view of the entrance into Penrhos Farm with the eastern gable of Building ID number 40 at the centre. Looking west-southwest.

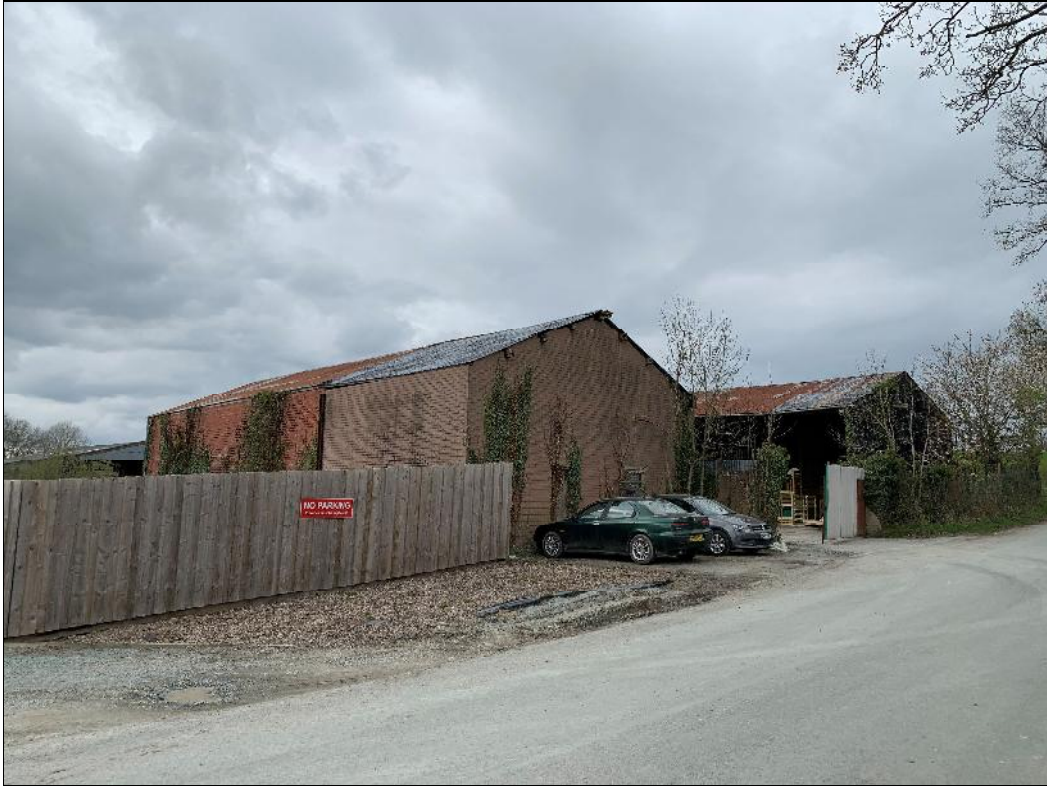
Plate 9: A view of the entrance into Deytheur Yard, with Building ID number 38 in the foreground and Building ID number 33 right of centre. Looking northwest.

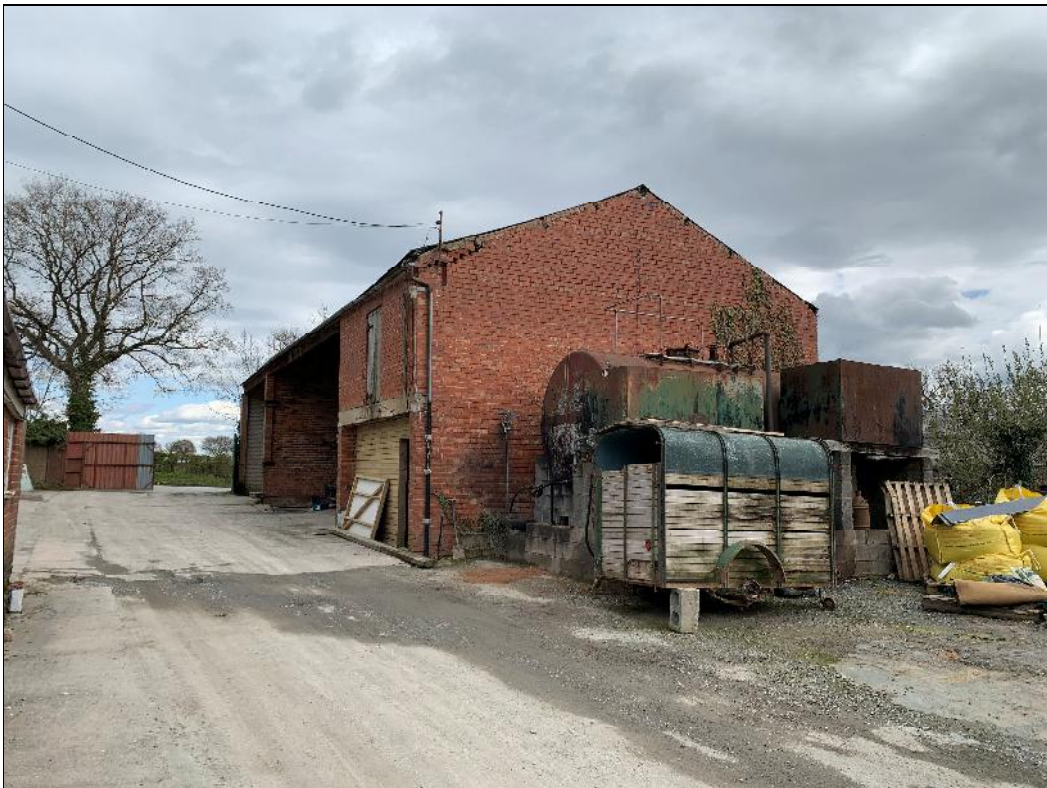
Plate 10: A view of Building ID number 38 in Deytheur Yard. Looking east.

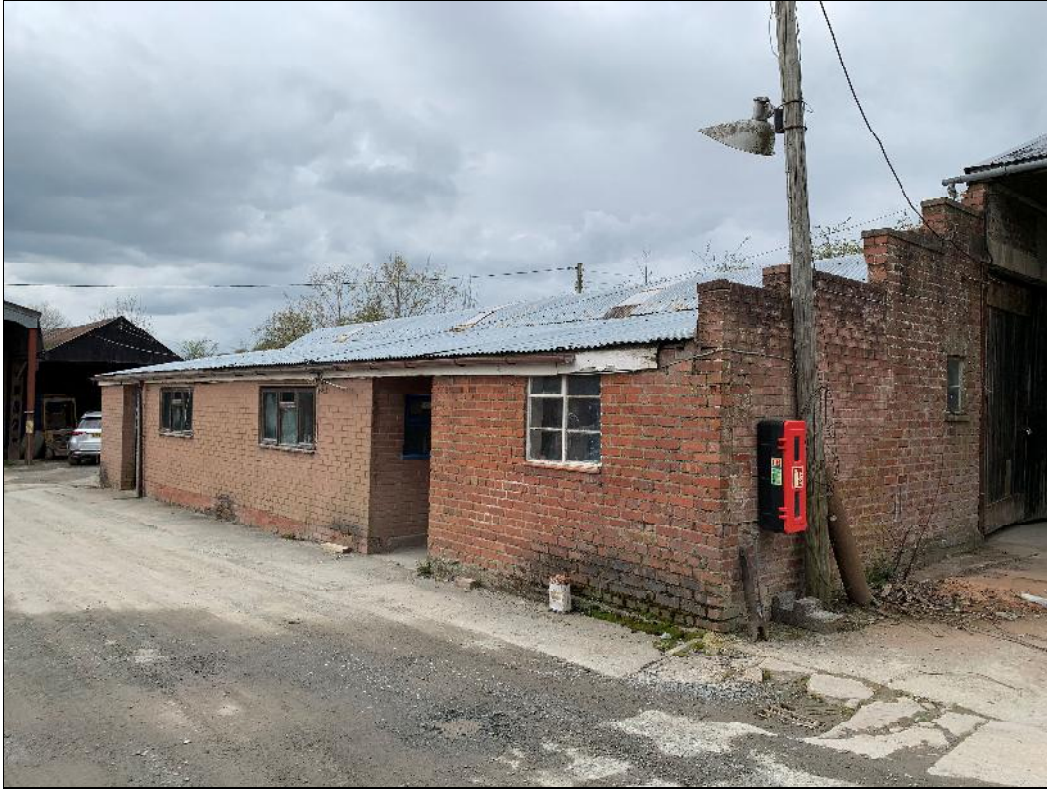
Plate 11: A view of Building ID number 44 in Deytheur Yard. Looking west-northwest.

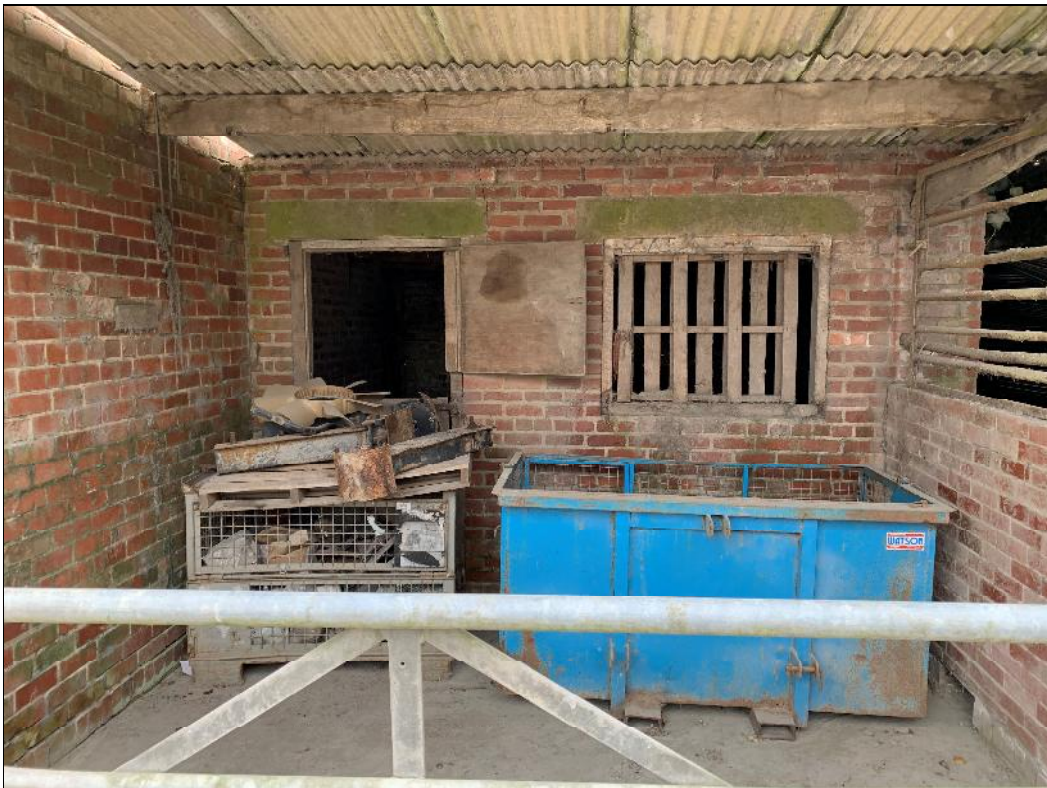
Plate 12: A view of the possible dog kennel in Building ID number 41 in Deytheur Yard. Looking south-southeast.

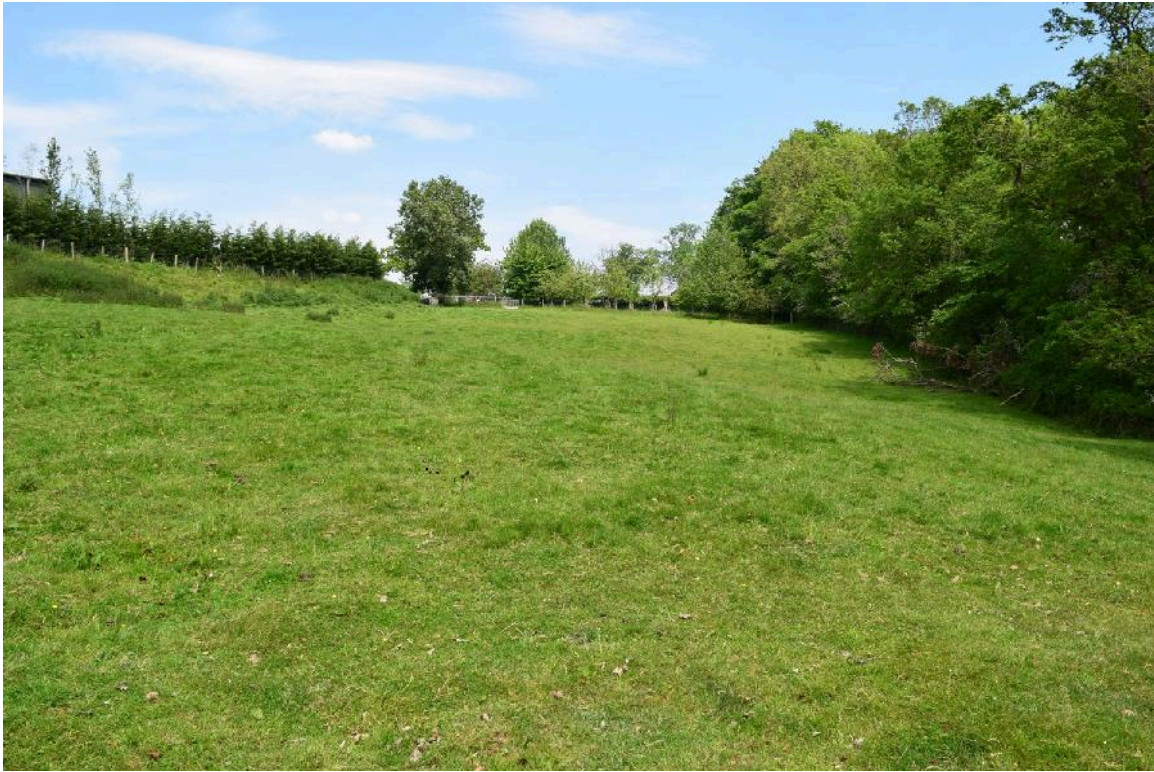
Plate 13: A view across the slope to the south of the steel frame building on which further planting will be carried out, looking northeast.

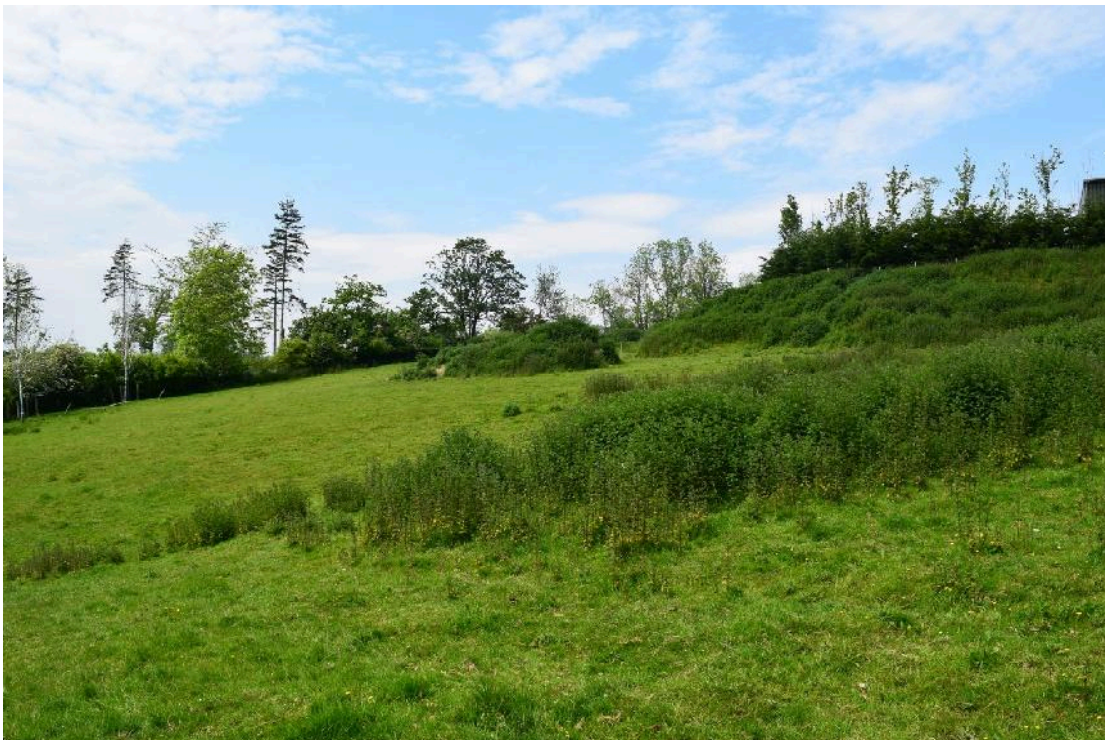
Plate 14: A view across the slope to the south of the steel frame building on which further planting will be carried out, looking west.

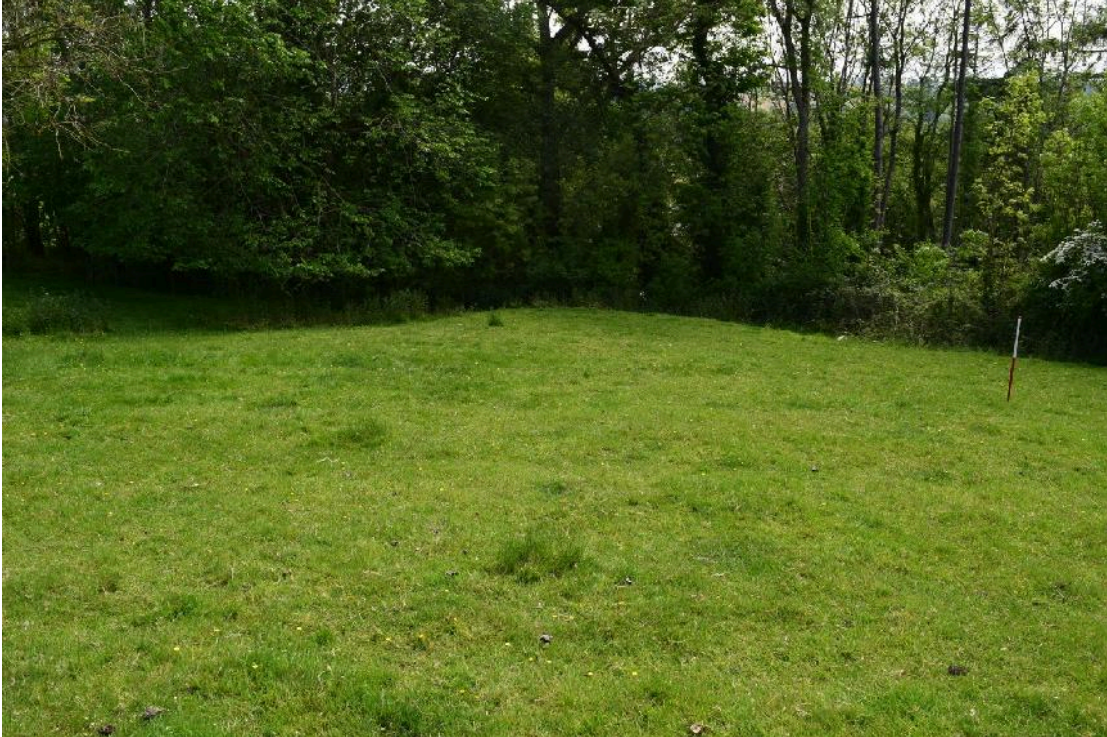
Plate 15: A view down slope to where the new pond will be located, looking south.
