## BS5837 Tree Survey, Arboricultural Impact Assessment and Method Statement.

Maelor Forest Nursery Fields Farm, Bronington, Wrexham, SY13 3HZ

12/10/20

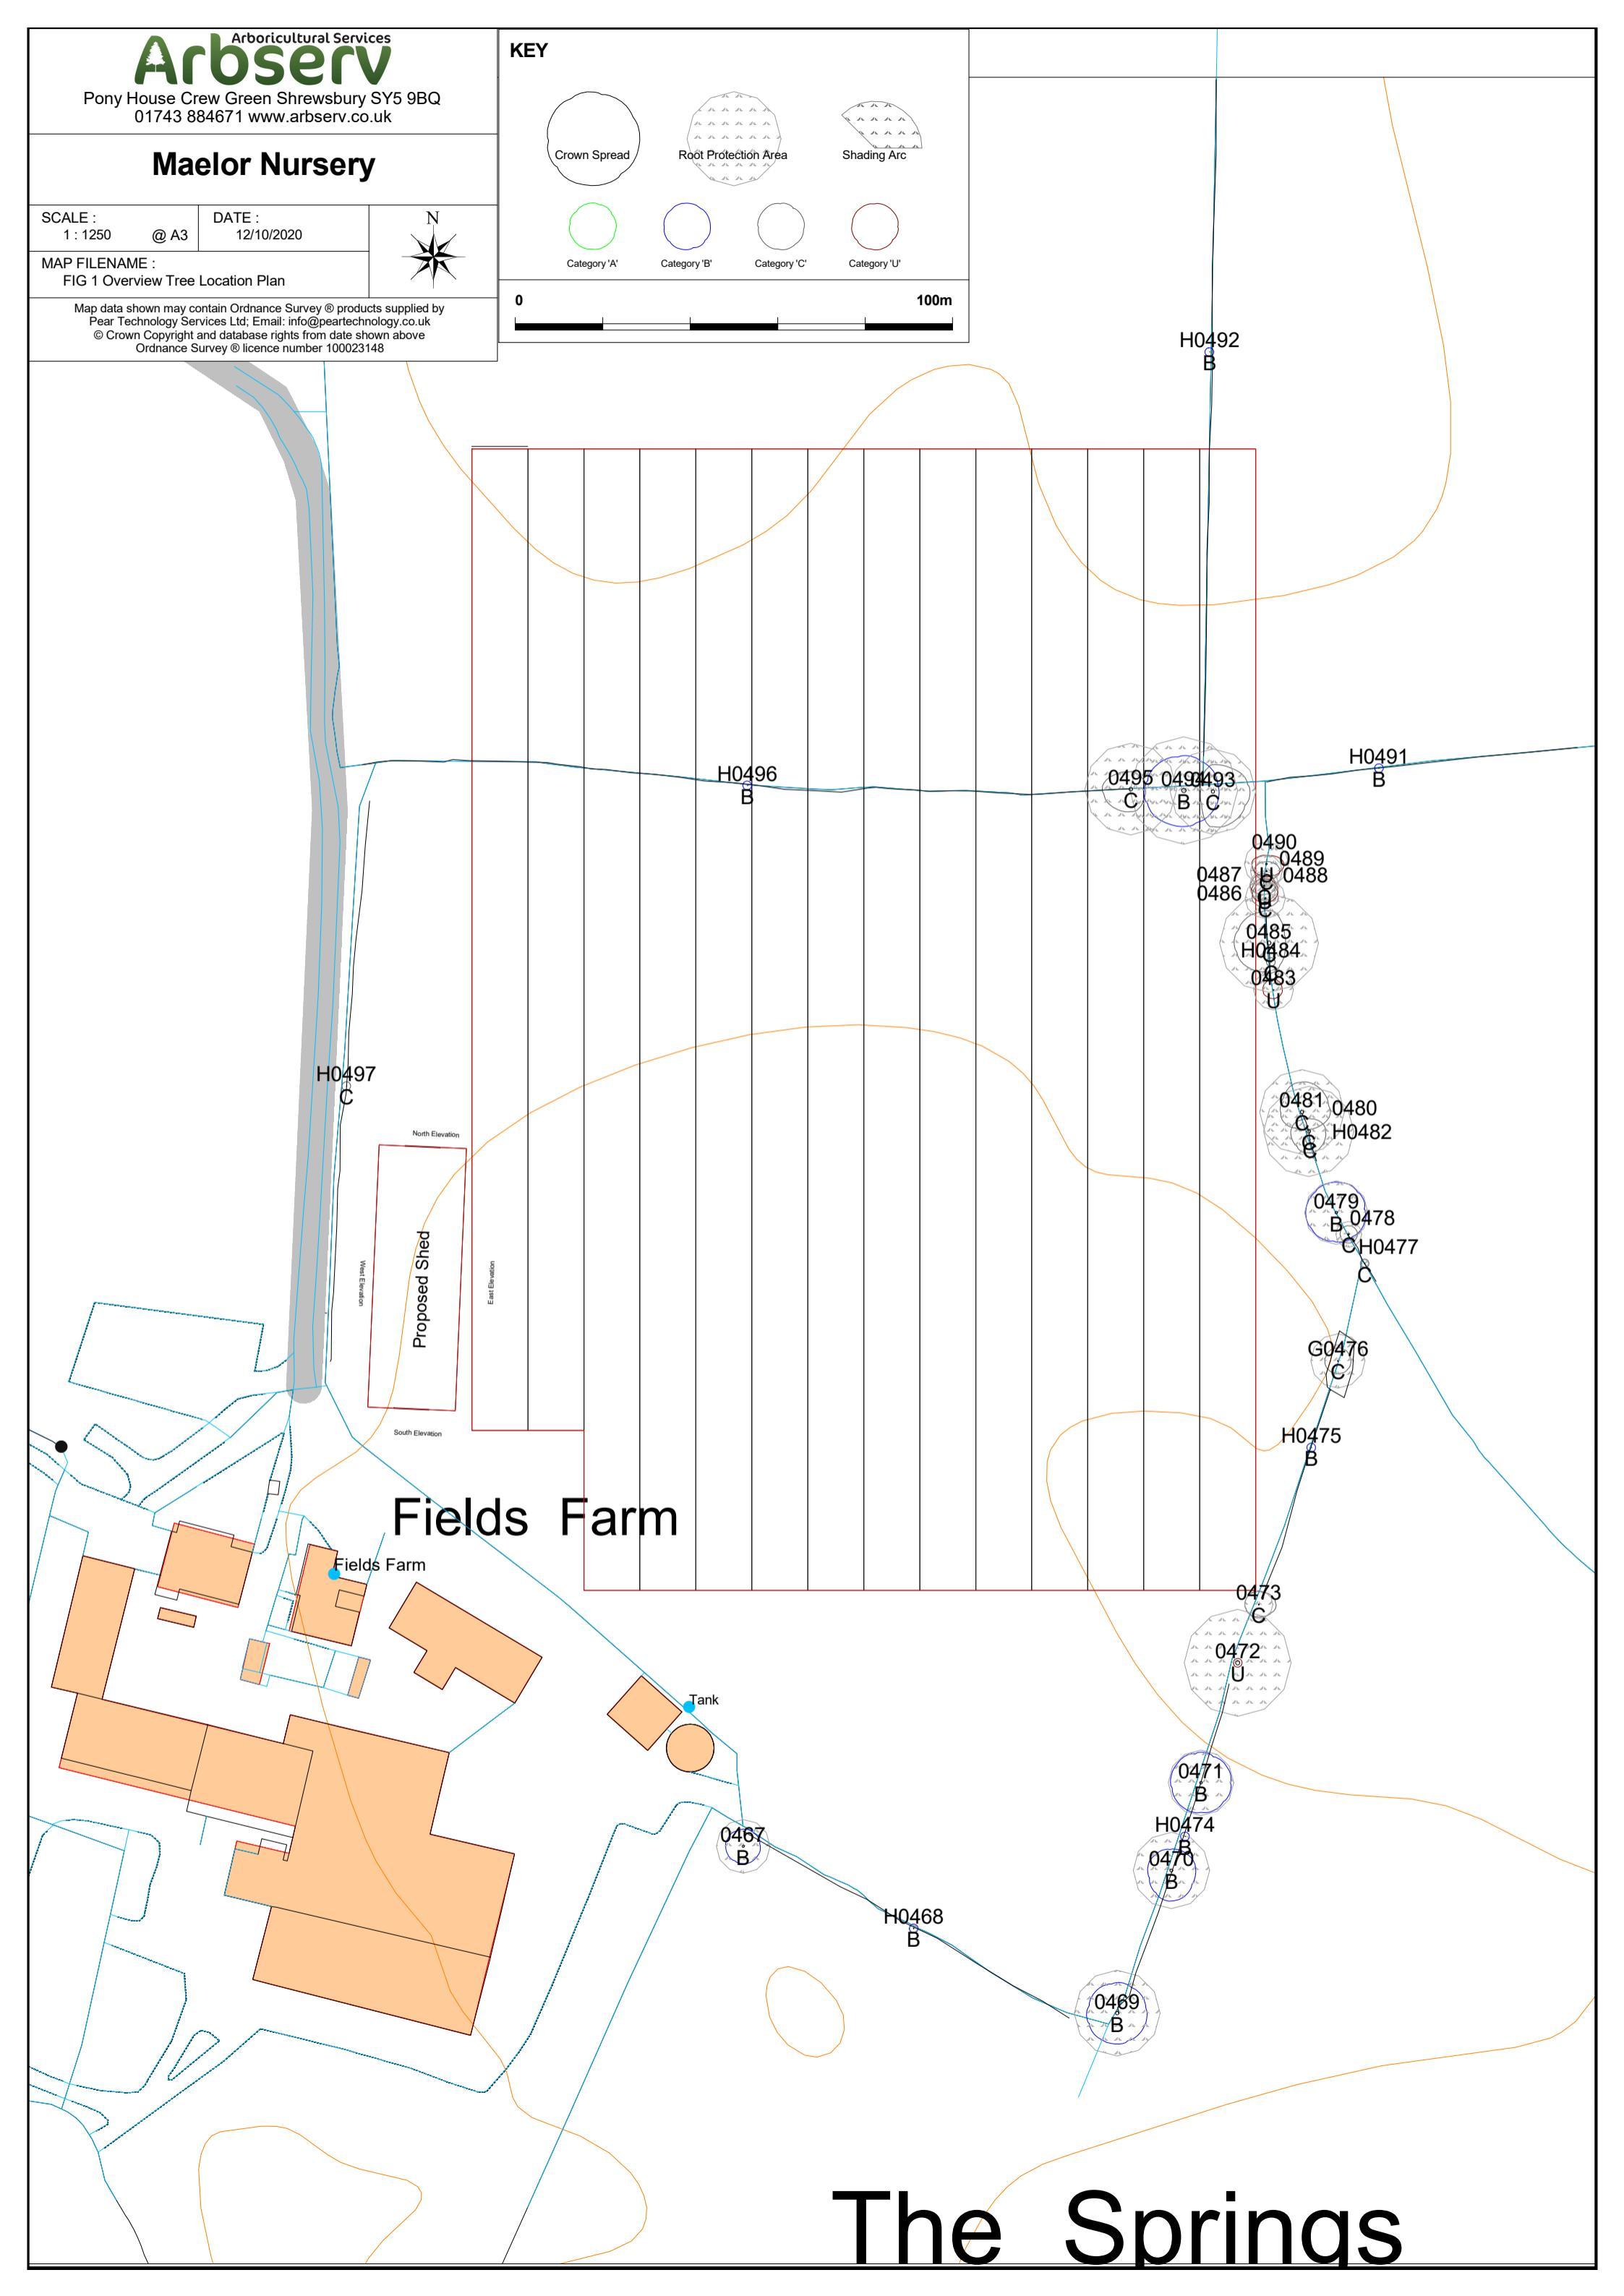
### Appendix 1 figure 1 tree location plan.

6.1 The survey was carried out on 07/10/20 by Luke Edwards, the weather at the time was clear and sunny with good visibility. Figure 1 shows the general layout of the site and the locations of all trees. The full results are tabulated in BS5837 tree survey schedule table (appendix 4) and should be read in conjunction with the tree protection plan Figure 3
