# **IMPACT ON SETTING AND SIGNIFICANCE RELATING TO A STEEL FRAMED BUILDING AND HAULAGE YARD AT PENRHOS FARM, PENRHOS, LLANYMYNECH, SY22 6QH**

Report by: Trysor

July 2021

Trysor Project No. 2021/782  
HER Event Record PRN – CPAT 164258

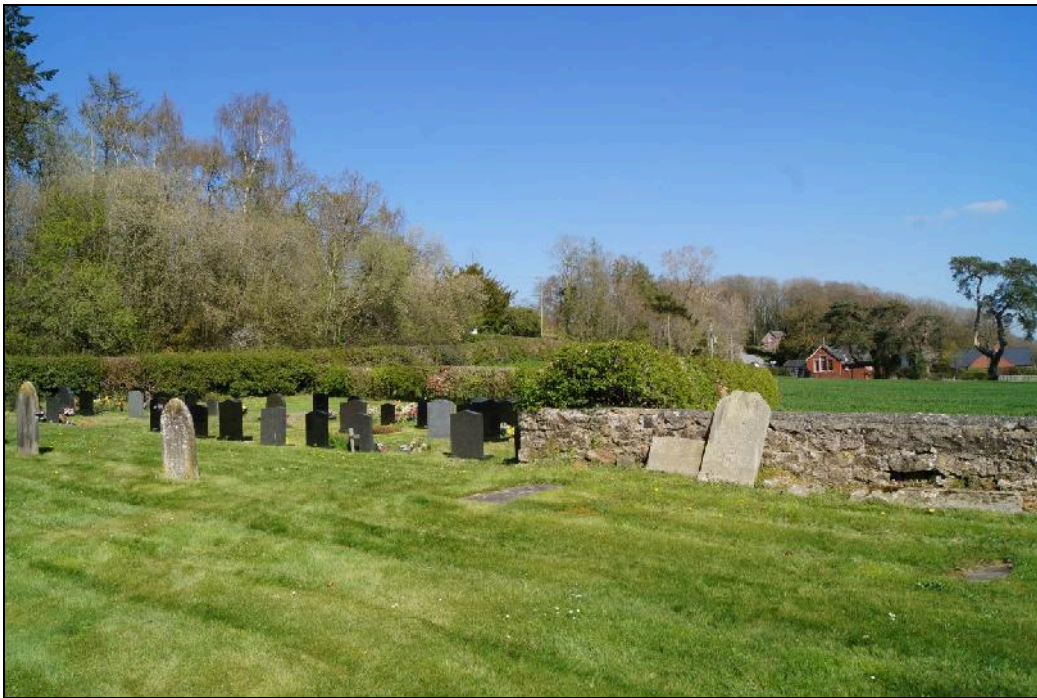
*Plate 18: A view from within Penrhos churchyard (SJ23685 16576) towards Penrhos Farm, April 2019. The new steel frame building there is not visible as it is blocked by trees on the intervening slope. The former red-brick school is right of centre and a modern house to the right of that. Looking northeast.*

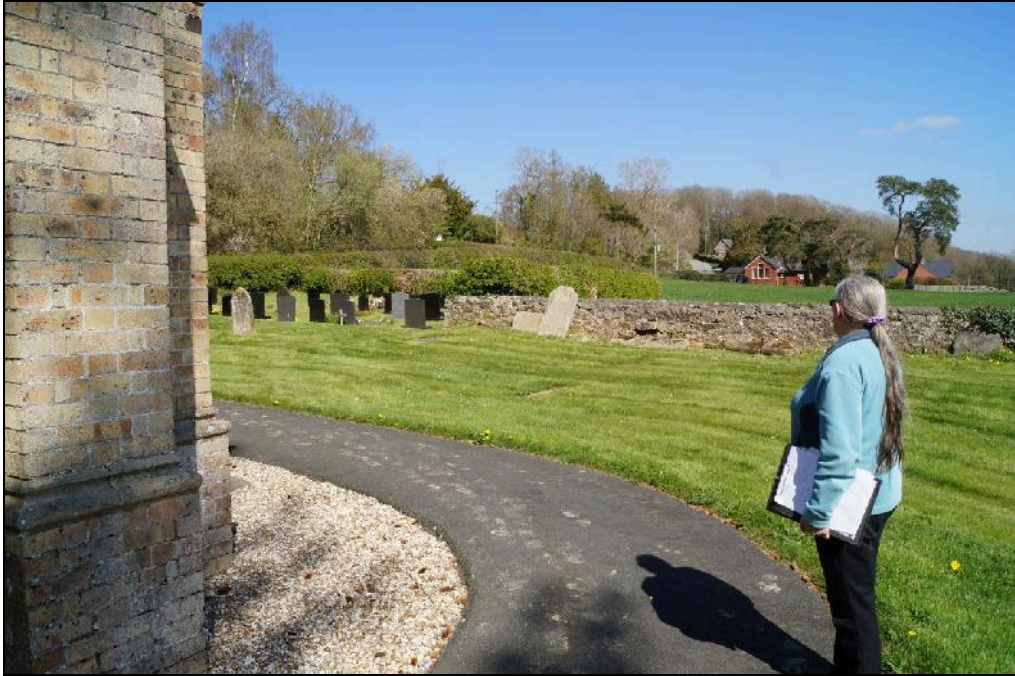
*Plate 19: A view from the front of Penrhos church itself (SJ23686 16588) towards Penrhos Farm, April 2019. The new steel frame building there is not visible as it is blocked by trees on the intervening slope. Looking northeast.*

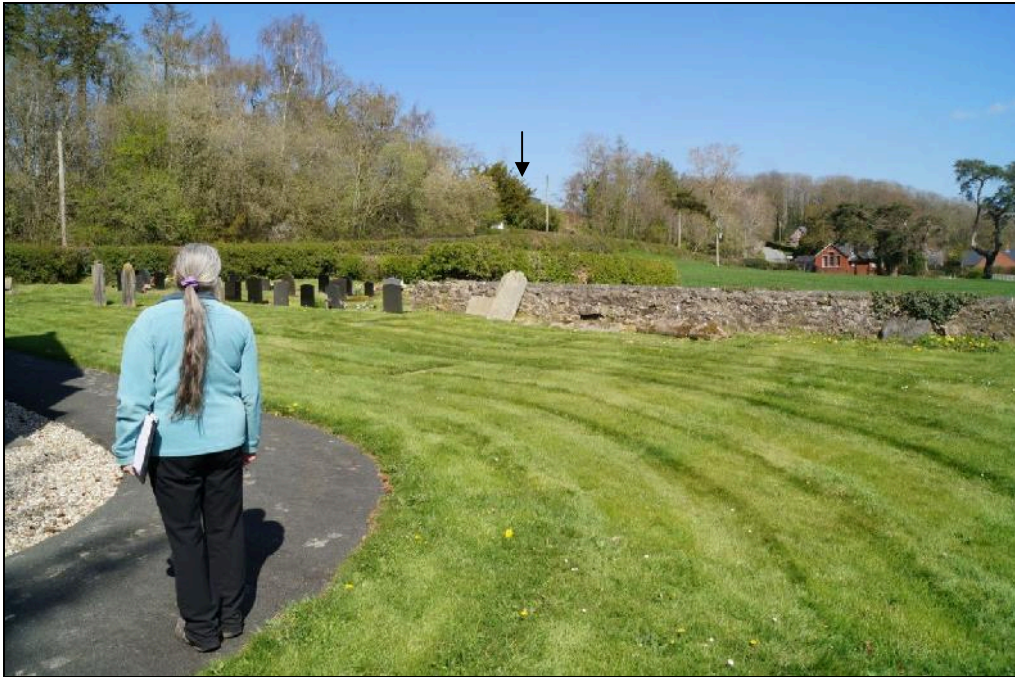
*Plate 20: A view towards Penrhos Farm from the front of Penrhos church itself (SJ23686 16584), taken in April 2019 from a few metres south of the view shown in Plate 36. A corner of the roof of the new steel frame building (black arrow) is just visible beyond the trees on the intervening slope. Looking northeast.*

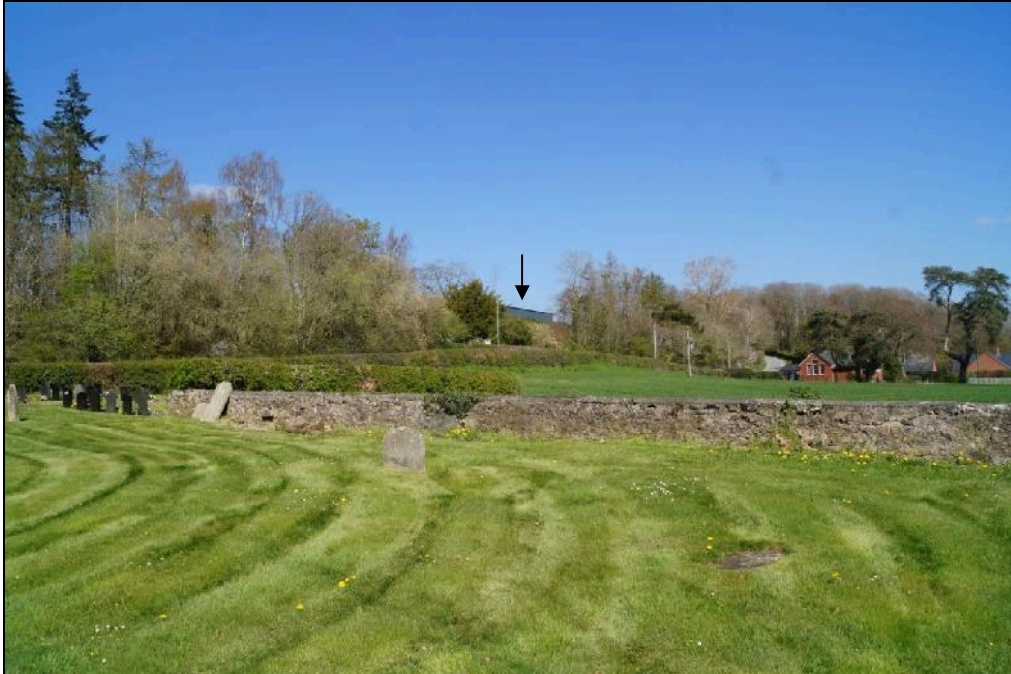
*Plate 21: A view towards Penrhos Farm from the front of Penrhos church itself (SJ23691 16582), taken in April 2019 from a few metres southeast of the view shown in Plate 36. The side of the new steel frame building is visible in this direction (black arrow), through a gap in the trees. The screening hedge on the bund in front of the shed will screen this view with time. New tree planting later added to the slope below the bund has further screened this view (see Plate 26) and more planting is proposed. Looking northeast.*

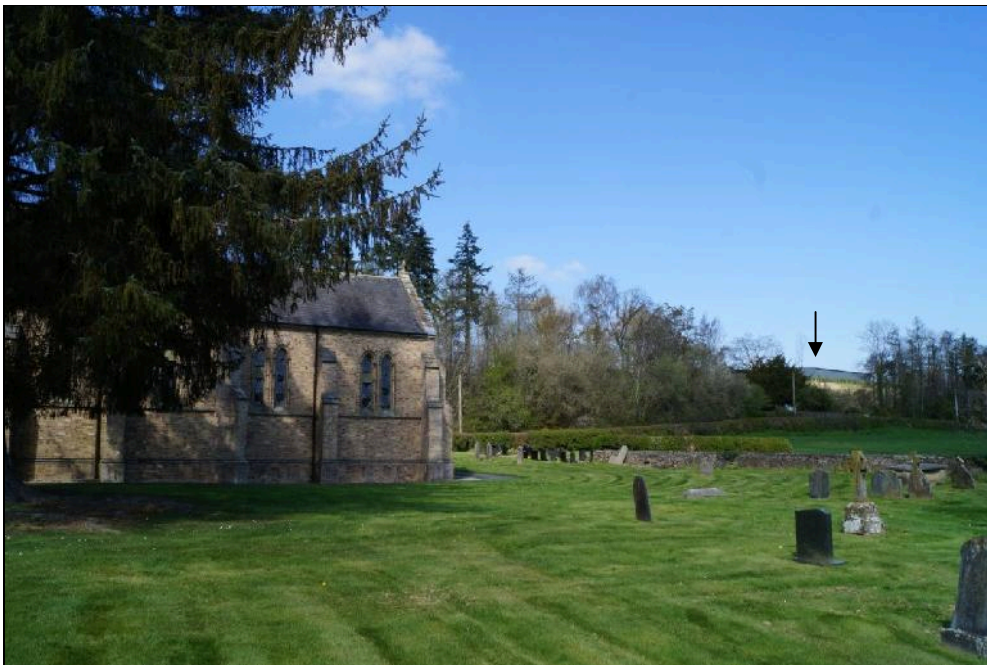
*Plate 24: A view taken in April 2019 from SJ23677 16564, shows the steel frame building at Penrhos Farm is partially visible in the peripheral view. This view was expected to change as the screening hedge grew in front of the steel frame building (black arrow), reducing any impact with time. Additional trees have been added since this photograph was taken, increasing the screening effect (see Plate 26), and more are proposed. Looking northeast.*

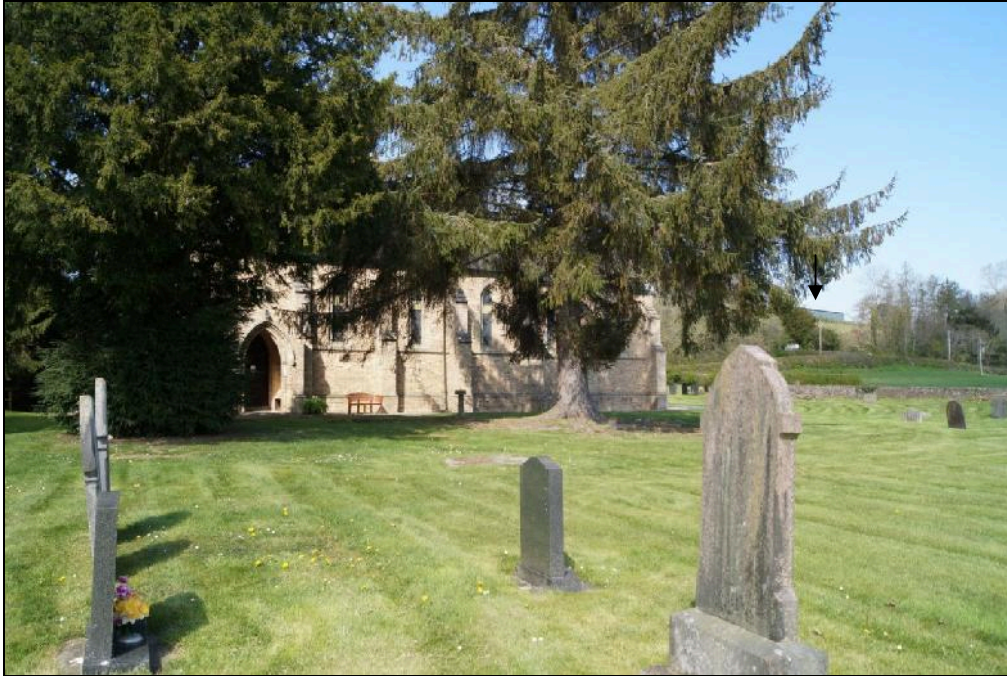
*Plate 25: A view taken from within the churchyard (SJ23668 16556), April 2019, shows the new steel frame building at Penrhos Farm (black arrow) is partially visible in the peripheral view, but not dominant and not causing a significant impact on views of the church or its setting. Looking north-northeast.*

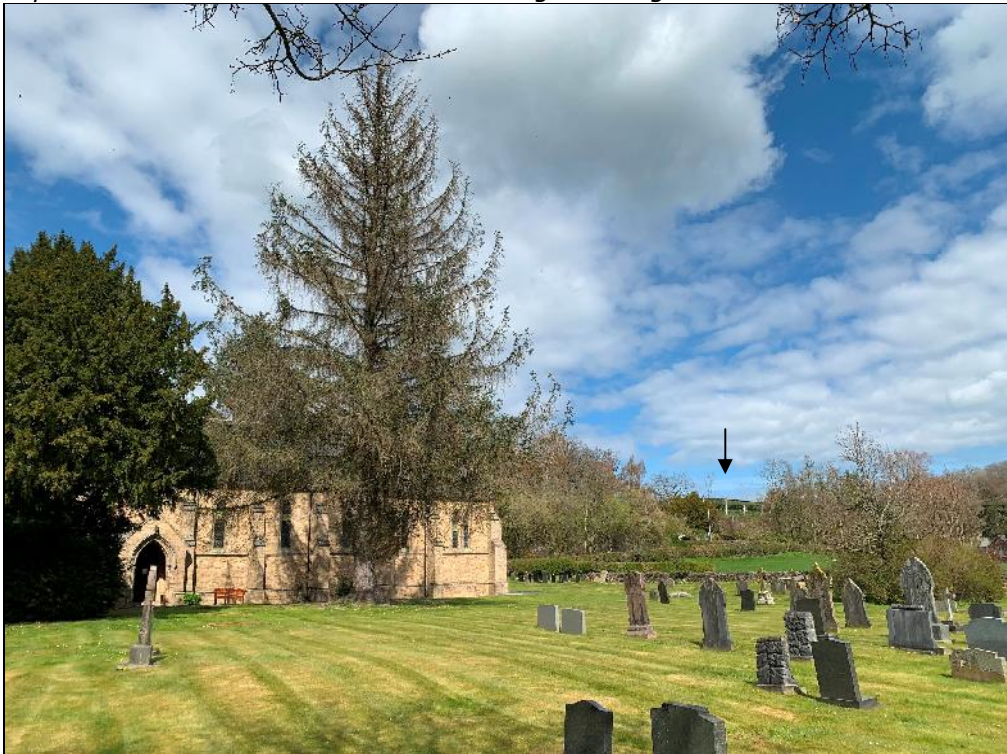
*Plate 26: A similar view to that shown in Plate 25, April 2021, showing how the leylandii hedge is maturing in front of the steel frame building at Penrhos Farm and new deciduous trees planted in the boundary to the south and within the leylandii hedge itself are helping to break up the view of the building, as predicted in 2019. Further tree planting is proposed in the same area. Looking northeast.*

<p>from where a full view of the church can be gained along with a view of the shed. It is still possible to visit the church, appreciate and understand its form and history and remain unaware of the existence of the shed. The shed is largely screened by trees and the topography when viewed from the eastern side of the churchyard and cannot be seen from the western side of the churchyard.</p> <p>A bund and screening hedge have been created along the southern side of the shed as mitigation to reduce the visual impact caused by the shed on views from the landscape to the south. The visual impact is already being reduced as the screening hedge has matured. Since 2019 deciduous trees have been added to strengthen the leylandii hedge along the bund and also in the field to the south of the bund, and more landscaping and tree-planting is proposed, which will increase the effectiveness of this mitigation.</p>

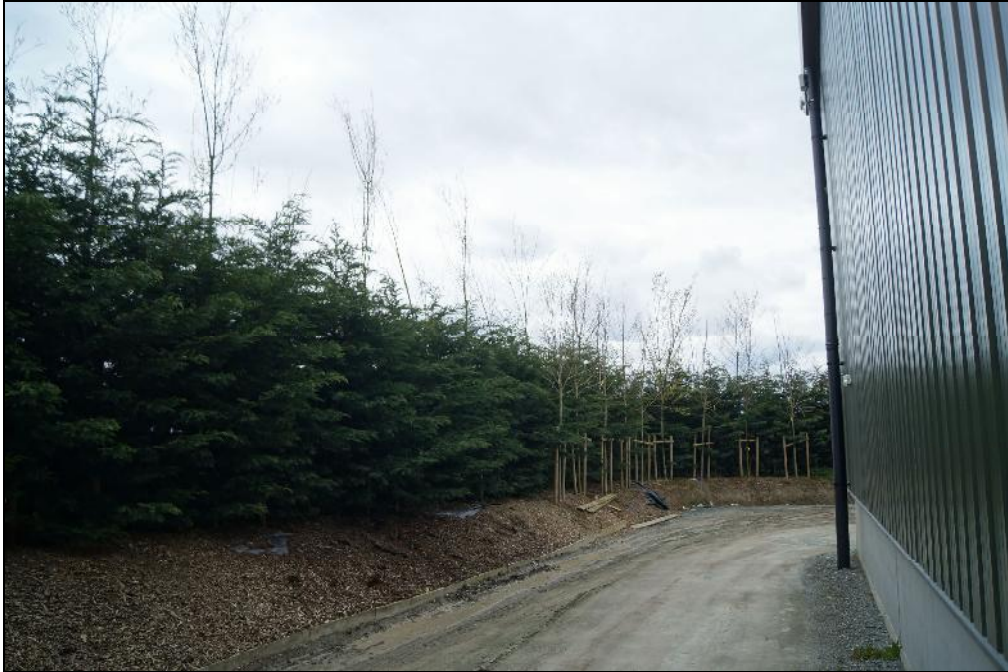
*Plate 37: A view of the leylandii hedge on the bund around the southern end of the new steel frame building at Penrhos Farm, April 2021, showing the deciduous trees planted since 2019 to increase the screening effect of the hedge. Looking west-southwest.*

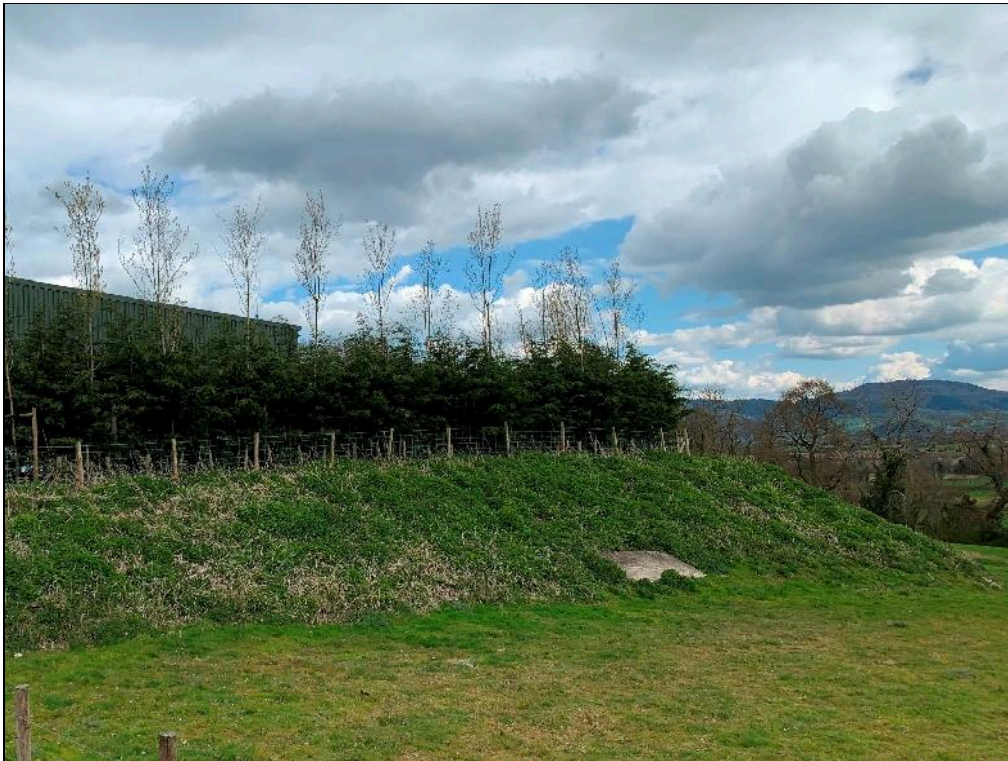
*Plate 38: A view of the bund around the southern end of the new steel frame building at Penrhos Farm, April 2021, showing the screening trees growing along the top of the bank with additional deciduous trees planted alongside the Leylandii hedge. Further trees will be planted in front of the bund in future. Looking east-northeast.*

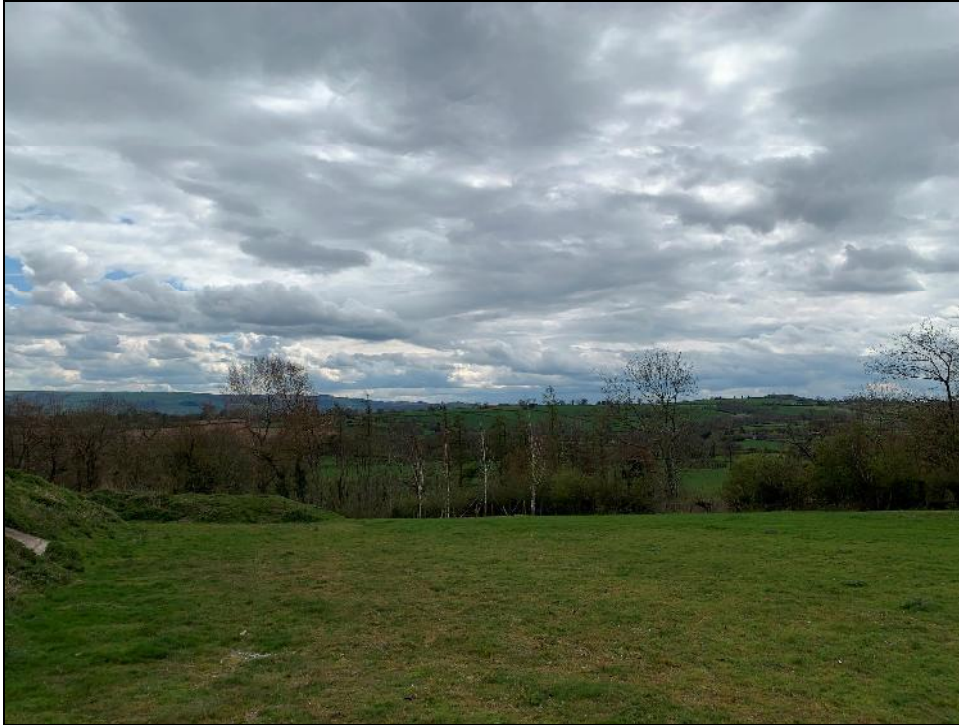
*Plate 39: A view of the deciduous trees planted to the south of the bund designed to help screen views from the area of Holy Trinity parish churchyard, April 2021. Further mitigations proposed include raising the ground level of the field and planting trees across the whole area shown here, to strengthen the screening effect. Looking south-southeast.*
